ADA Curb Ramp New Construction Inspection Form (Perpendicular)

Nw 313 th ave

Project No.

Nw Yorkshire st

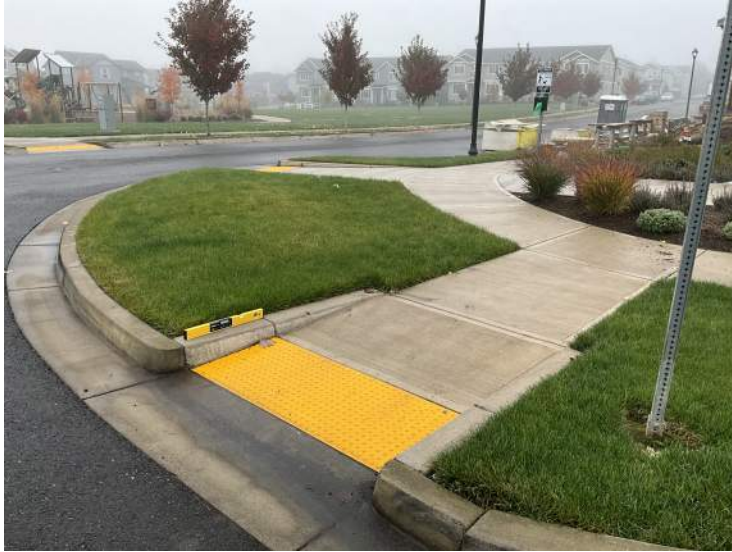
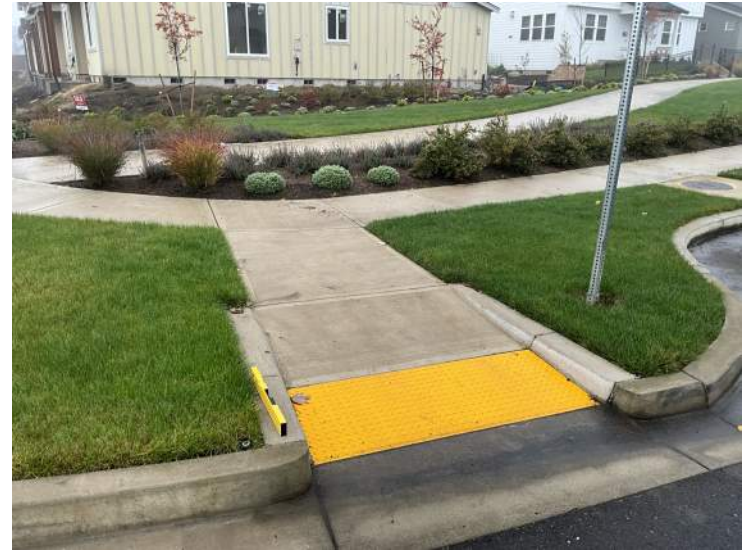
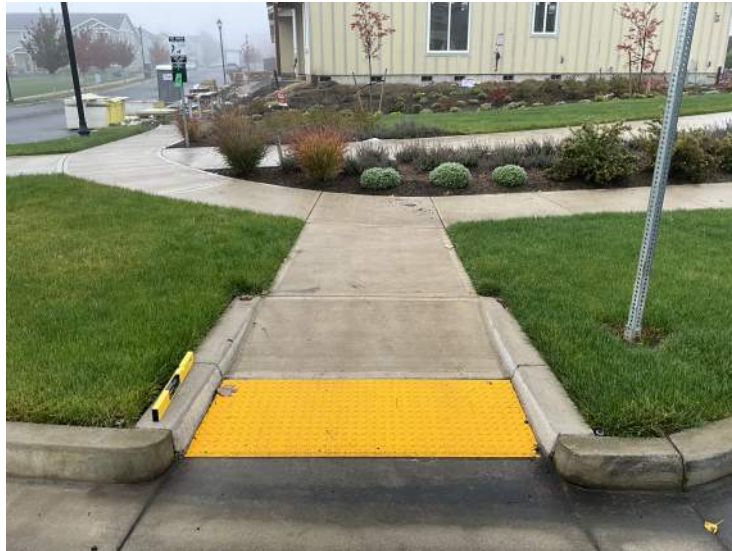
ADA Curb Ramp Images

RR1 ic RR
