# ADA Curb Ramp New Construction Inspection Form (Perpendicular)

NW Main

23885.56

NW Lenox

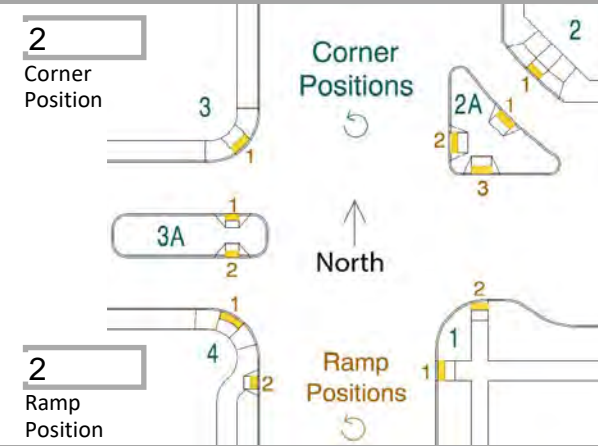
- Pedestrian Access Route (to measure Clear Width)
- Detectable Warning Surface
- Cross Slope (2.0% max.)
- Running Slope (8.3% max.)
- Counter Slope (5.0% max.)
- Turning Space (X & Y) (2.0% max. / 4' x 4' min.)\*  
\* If constrained at back of walk, min. Y length is 5'.
- Gutter Flow Slope (as directed)
