ADA Curb Ramp New Construction Inspection Form (Perpendicular)

North-South Road Name

Intersection No.

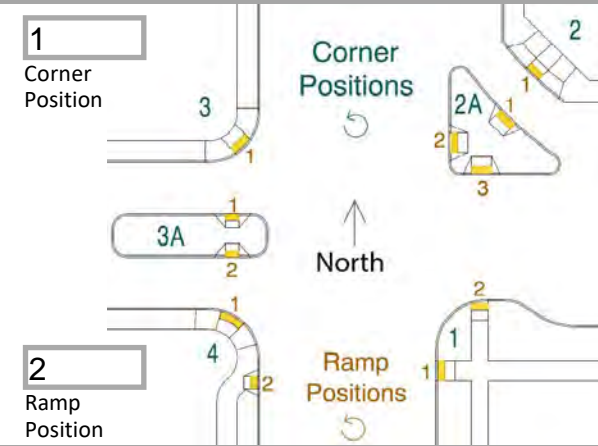
Poor craftsmanship in gutter area

PERPENDICULAR RAMP (PR)

Pedestrian Access Route (to measure Clear Width)

Detectable Warning Surface

Cross Slope (2.0% max.)

Running Slope (8.3% max.)

Counter Slope (5.0% max.)

Turning Space (X & Y) (2.0% max. / 4' x 4' min.)*
* If constrained at back of walk, min. Y length is 5'.

Gutter Flow Slope (as directed)
