ADA Curb Ramp New Construction Inspection Form (Perpendicular)

Nw 287

24952.54

Nw may

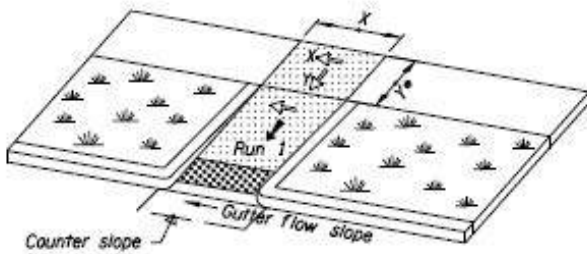
PERPENDICULAR RAMP (PR)

■ Pedestrian Access Route (to measure Clear Width)

■ Detectable Warning Surface

↔ Cross Slope (2.0% max.)

← Running Slope (8.3% max.)

↗ Counter Slope (5.0% max.)

↻ Turning Space (X & Y) (2.0% max. / 4' x 4' min.)*
* If constrained at back of walk, min. Y length is 5'.

→ Gutter Flow Slope (as directed)

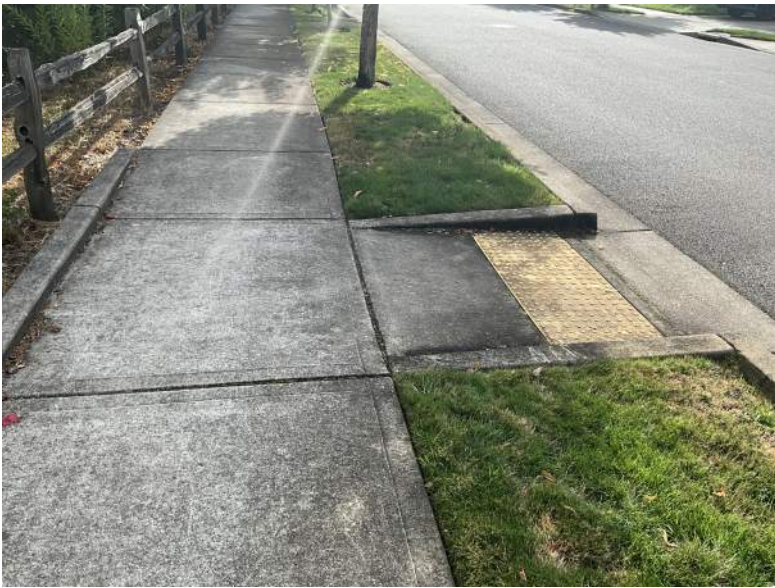
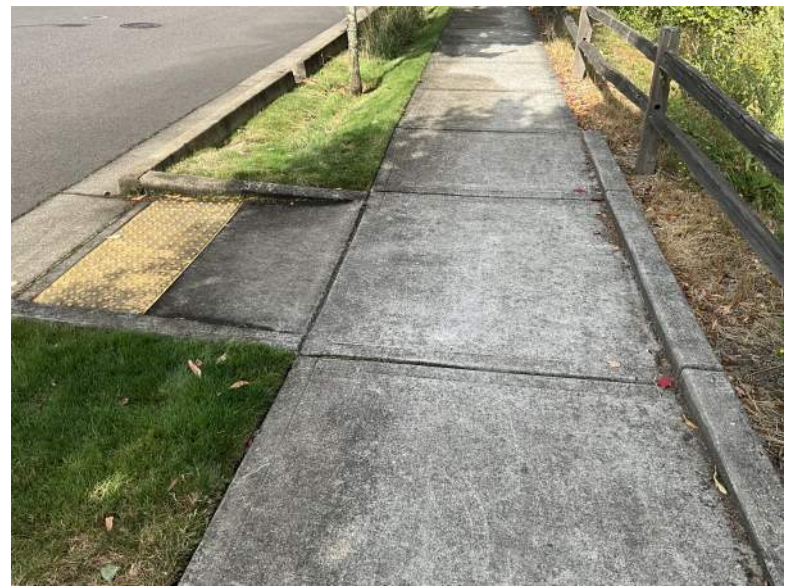
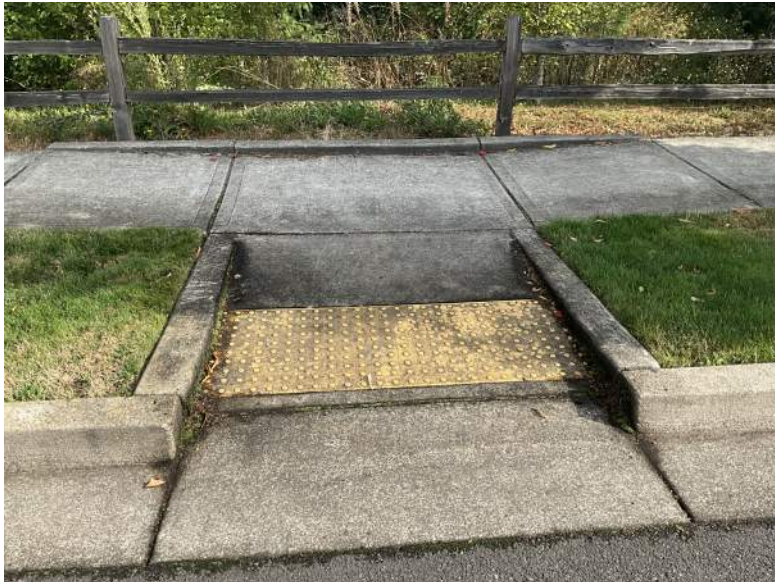
ADA Curb Ramp Images

IITD RR1 fail
