ADA Curb Ramp New Construction Inspection Form (Perpendicular)

Nw 291 st

23885.56

Nw fair st

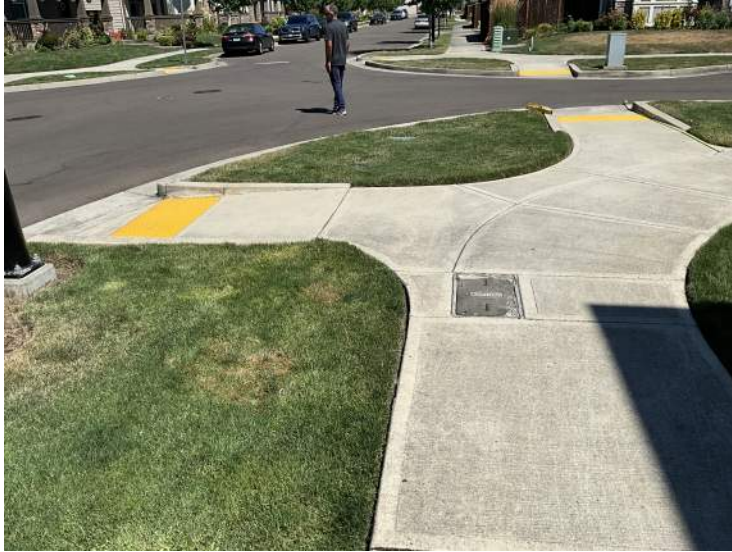
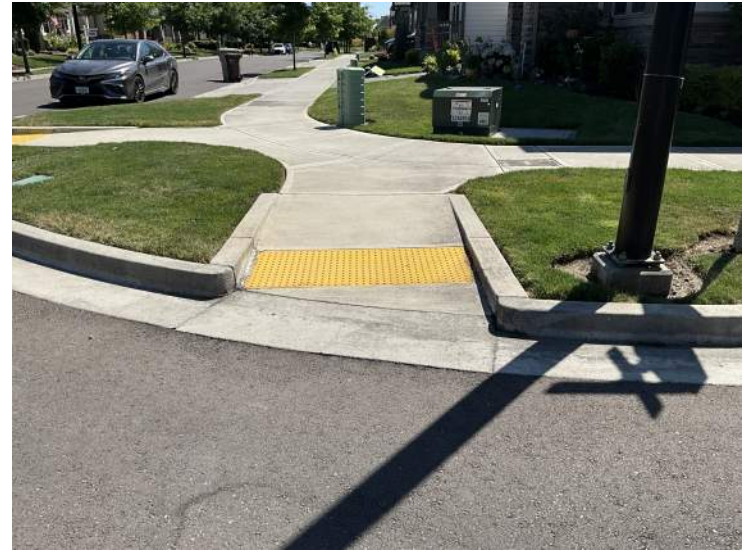
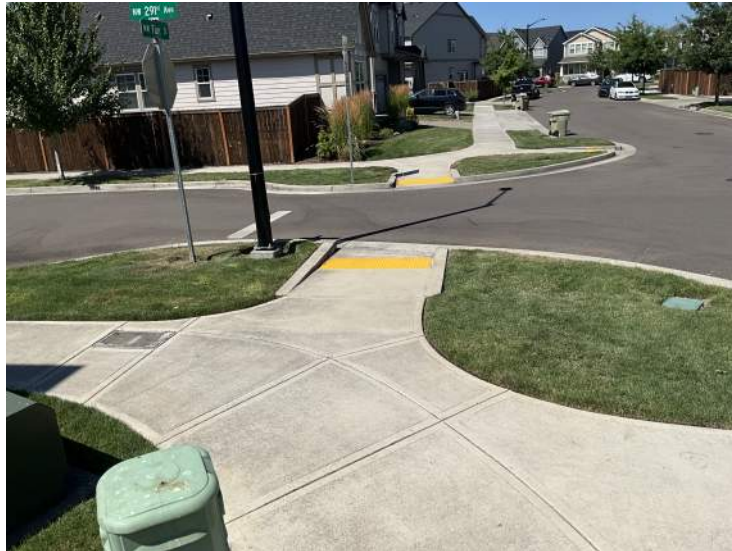
ADA Curb Ramp Images

Tool joint in turn space rr1 icrr
