# ADA Curb Ramp New Construction Inspection Form (Perpendicular)

Nw Kaye

24952.54

NW King

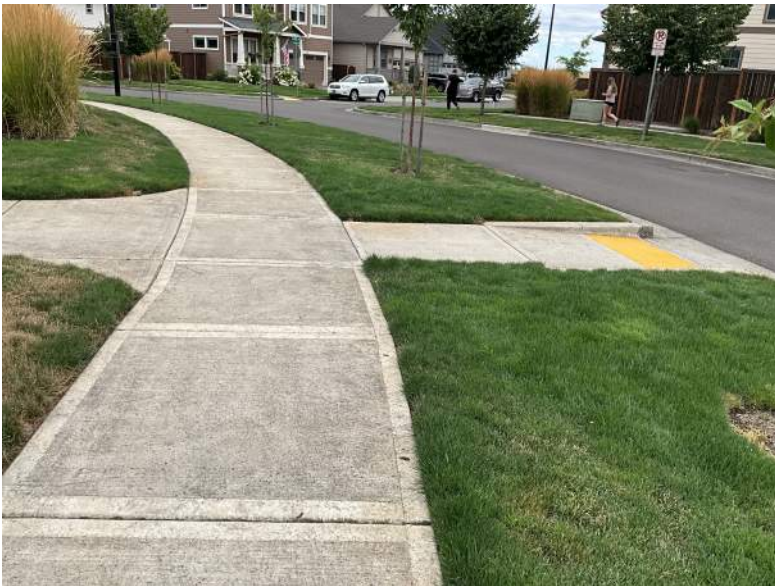
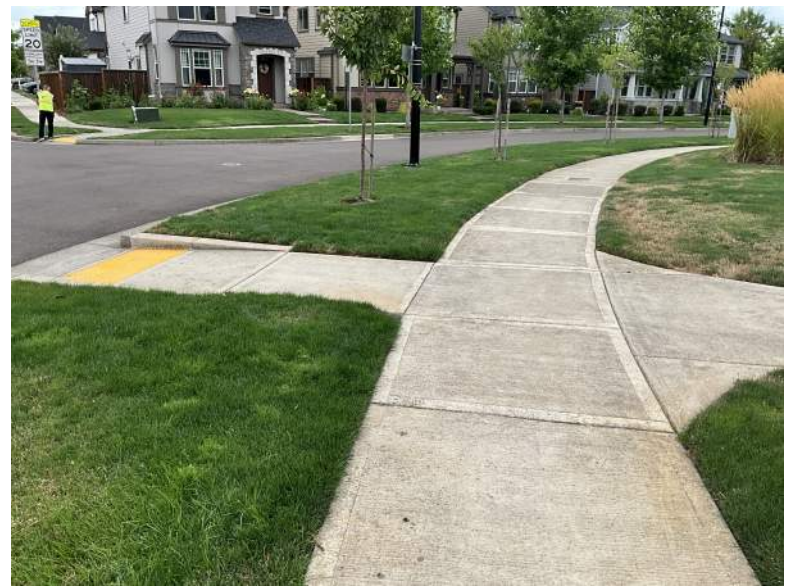
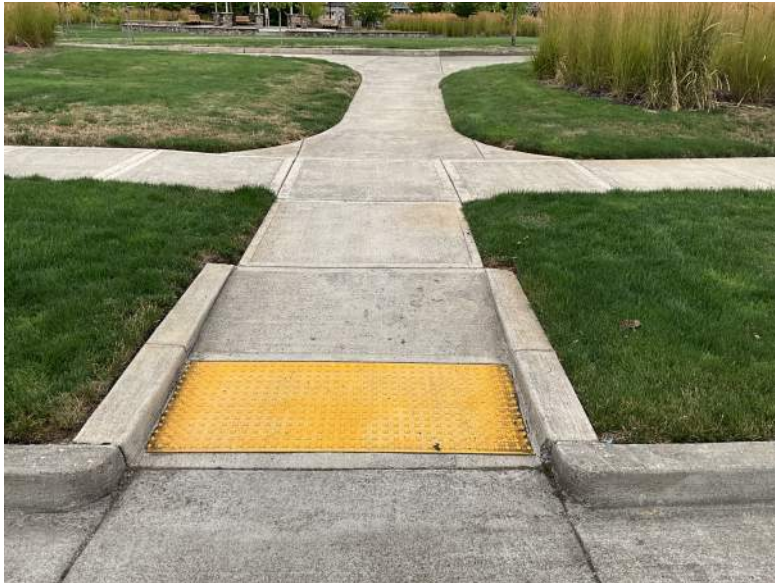
## ADA Curb Ramp Images

RR1 ICRR, IITD
