ADA Curb Ramp New Construction Inspection Form (Perpendicular)

Nw 293rd

Project No.

NW Keenon

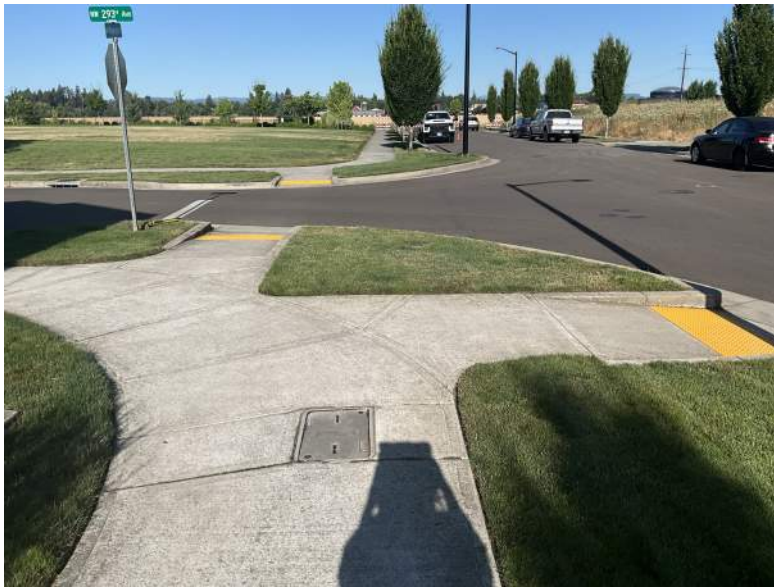
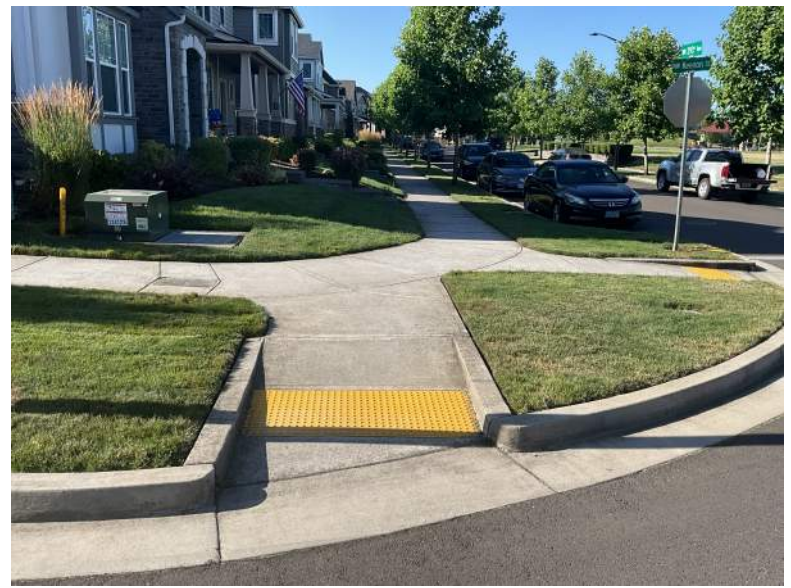
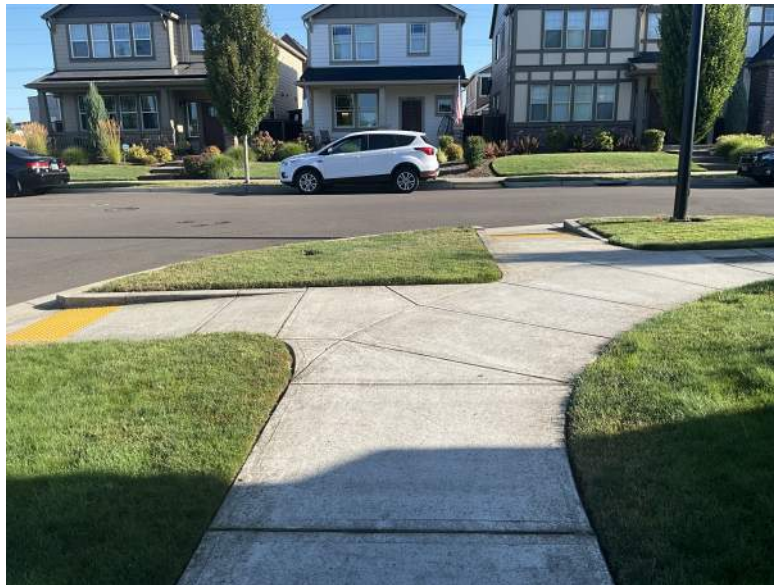
ADA Curb Ramp Images

Running Slope 1

8.4

☒

Slope X

2.7

Control joint center of TS
