# ADA Curb Ramp New Construction Inspection Form (Perpendicular)

NW Kaye

24952.54

NW Fair

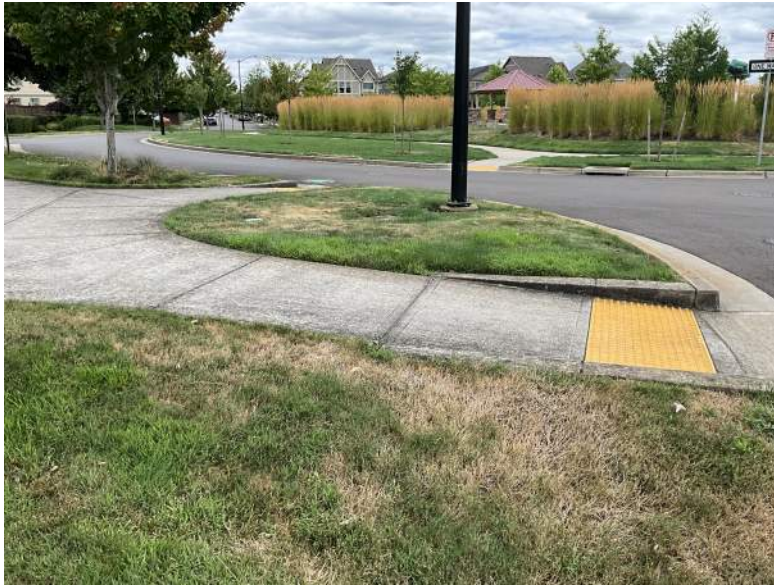
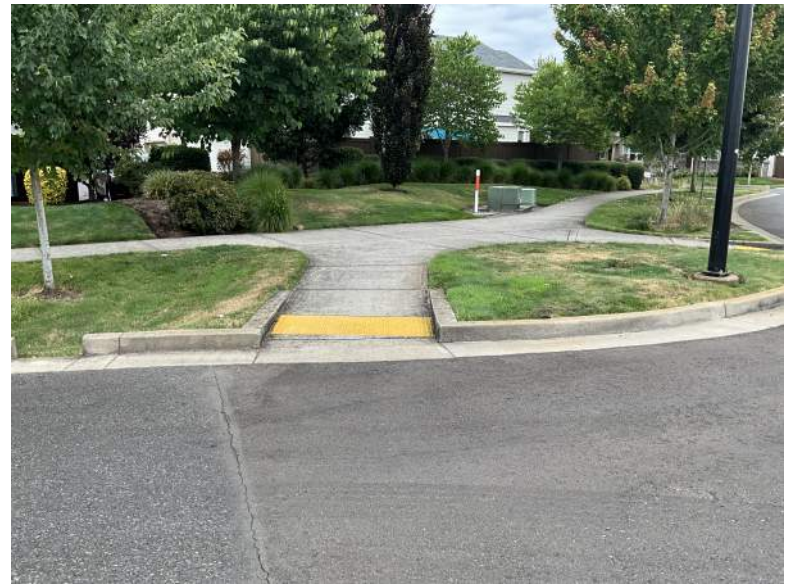
## ADA Curb Ramp Images

RR1 ICRR
