ADA Curb Ramp New Construction Inspection Form (Combination)

NW 287th Ave

NW Mays St

COMBINATION RAMP (C)

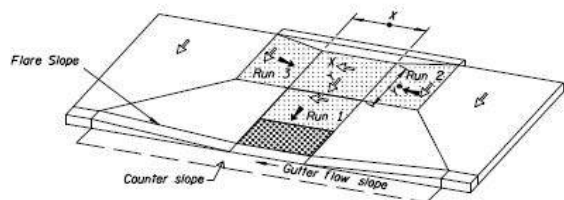
- Pedestrian Access Route (to measure Clear Width)
- Detectable Warning Surface
- Cross Slope (2.0% max.)
- Running Slope (8.3% max.)
- Counter Slope (5.0% max.)
- Turning Space (X & Y) (2.0% max. / 4' x 4' min.)*
* If constrained at back of walk, min. Y length is 5'.
- Gutter Flow Slope (as directed)
