ADA Curb Ramp New Construction Inspection Form (Perpendicular)

nw 311 th ave

Project No.

Nw timeric dr

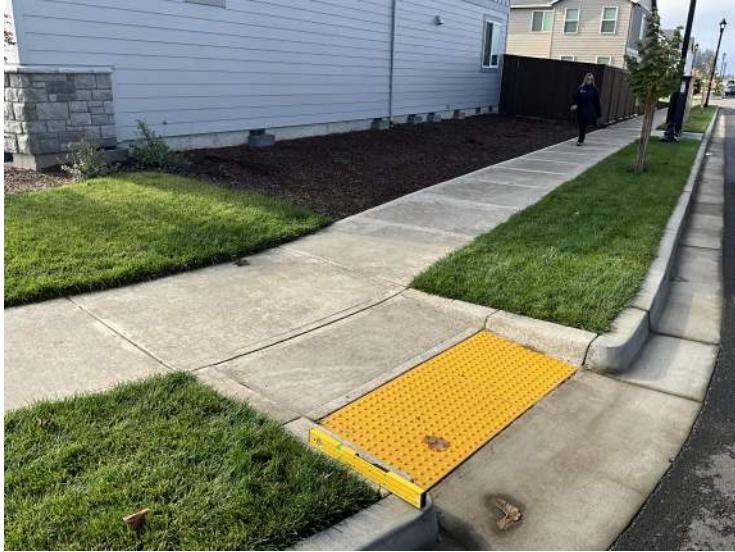
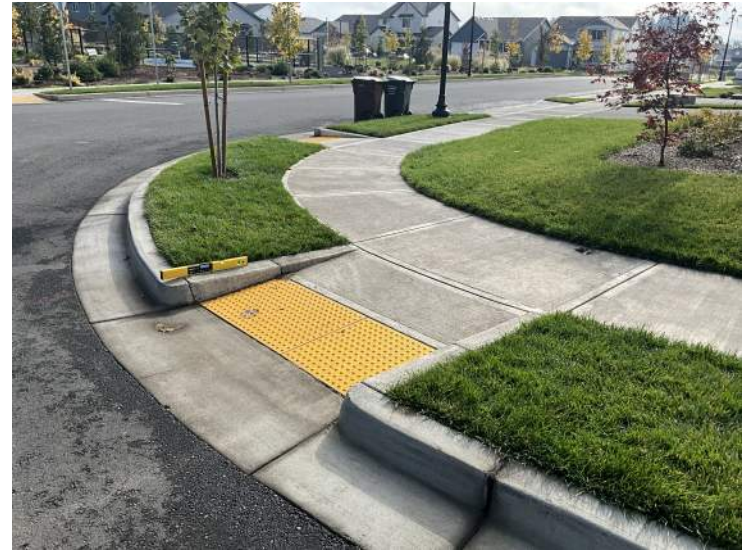
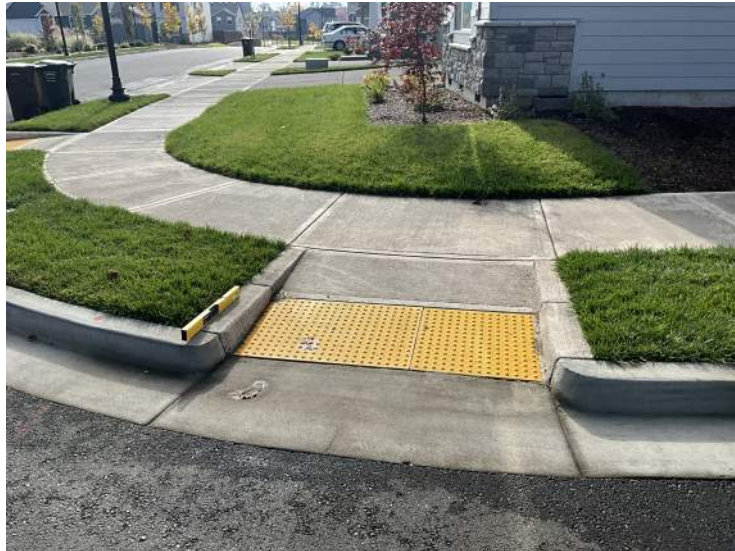
ADA Curb Ramp Images

Crack curb an gutter
