ADA Curb Ramp New Construction Inspection Form (Perpendicular)

NW Glencoe Rd

Project No.

NW McKay Creek Ct

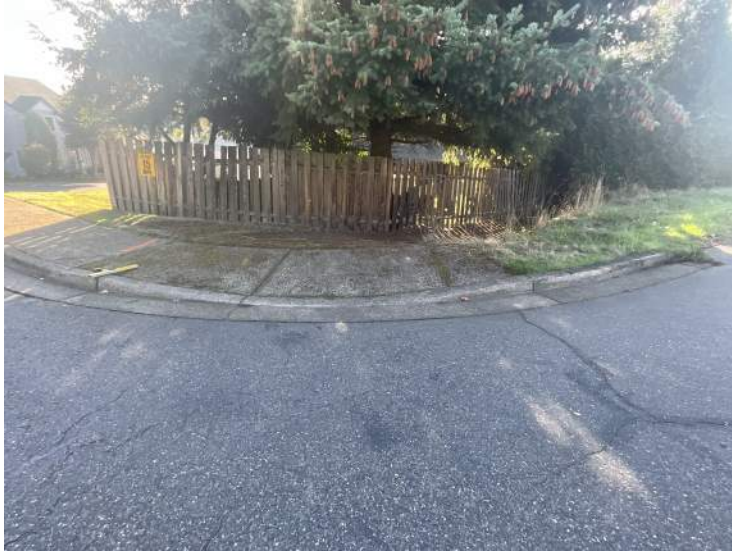
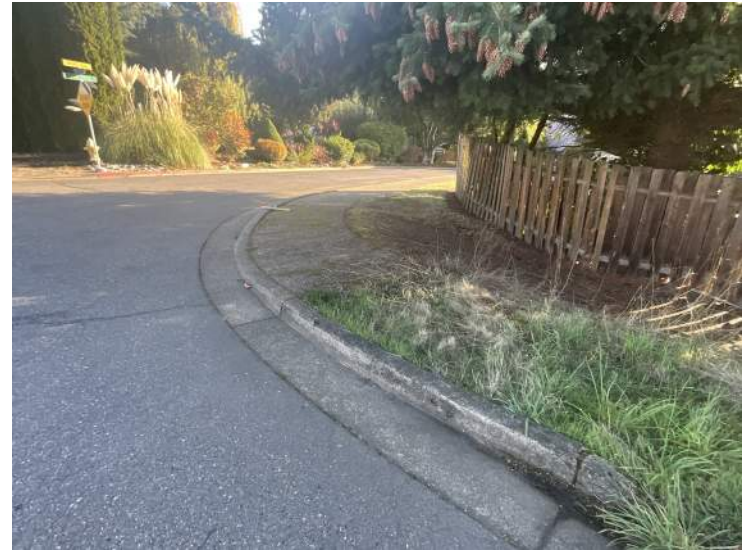
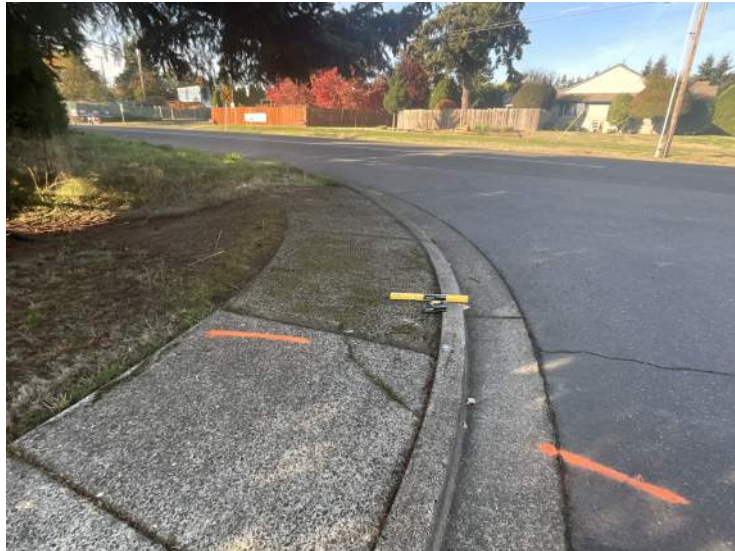
ADA Curb Ramp Images

Crack in curb and gutter
