ADA Curb Ramp New Construction Inspection Form (Combination)

NW 307th

23885.56

NW Pacific

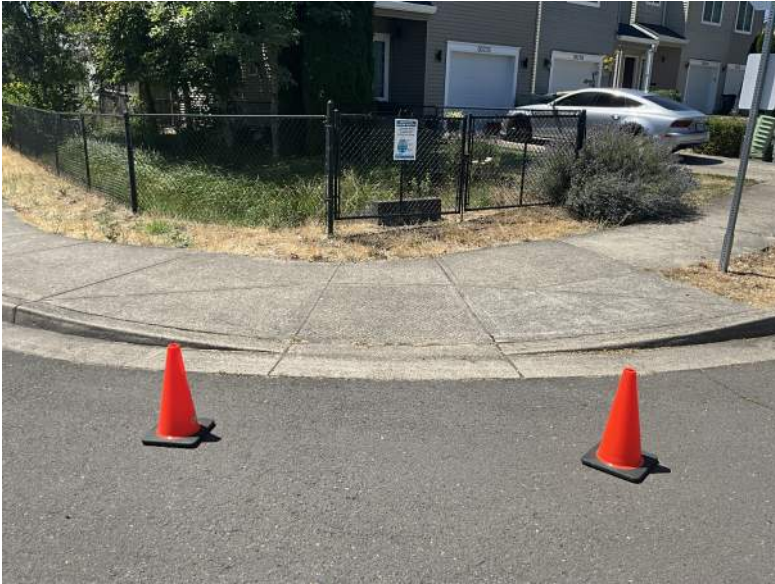
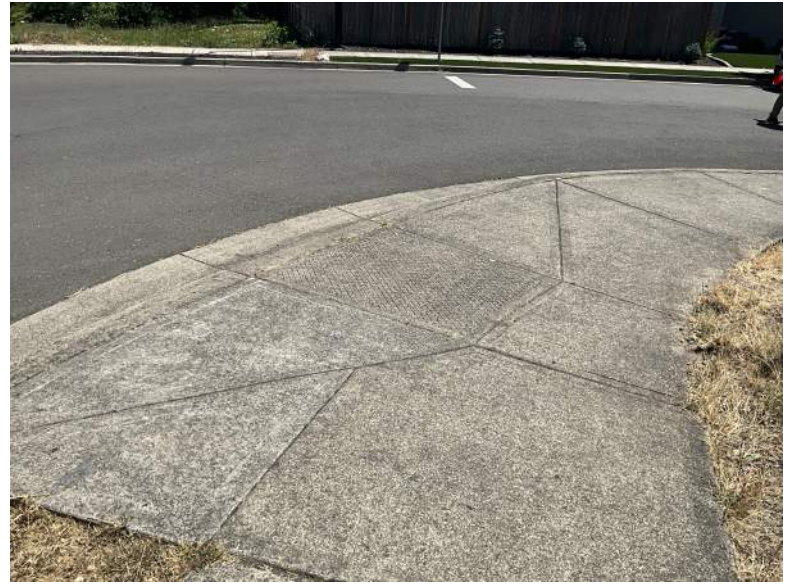
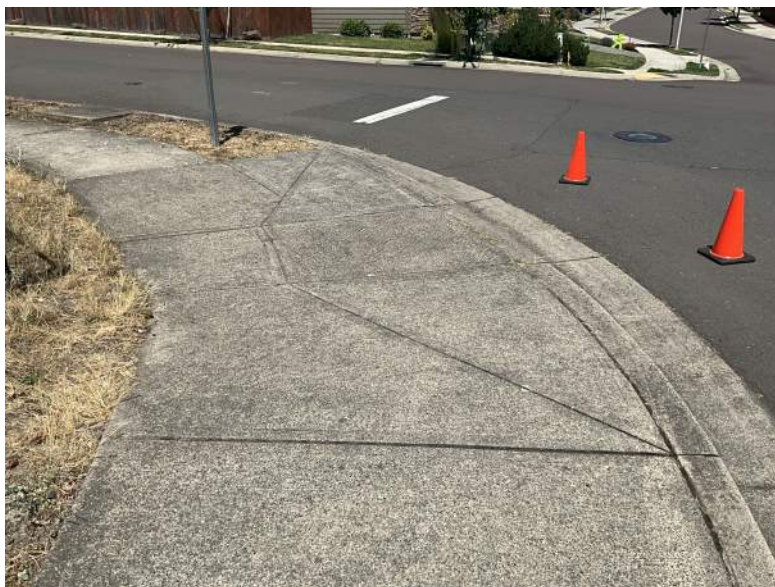
ADA Curb Ramp Images

RR2/RR3 clear width 74', IITD
