ADA Curb Ramp New Construction Inspection Form (Perpendicular)

NW 313th

24952.54

East-West Road Name

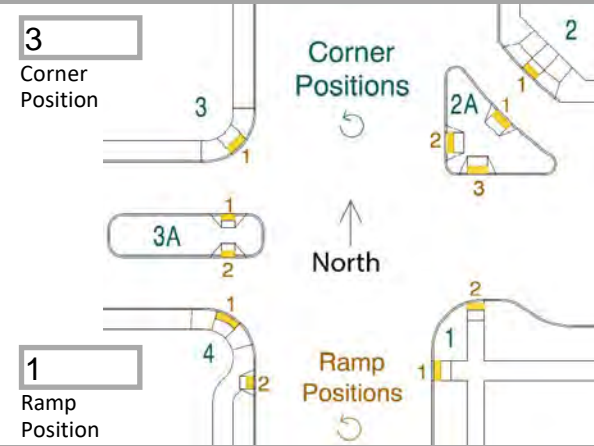
PERPENDICULAR RAMP (PR)

- Pedestrian Access Route (to measure Clear Width)
- Detectable Warning Surface
- Cross Slope (2.0% max.)
- Running Slope (8.3% max.)
- Counter Slope (5.0% max.)
- Turning Space (X & Y) (2.0% max. / 4' x 4' min.)*
* If constrained at back of walk, min. Y length is 5'.
- Gutter Flow Slope (as directed)
