# ADA Curb Ramp New Construction Inspection Form (Perpendicular)

Nw 292nd

23885.56

Nw Keenon

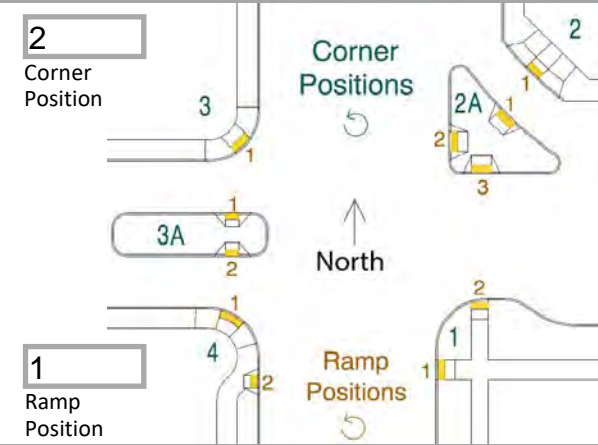
## PERPENDICULAR RAMP (PR)

■ Pedestrian Access Route (to measure Clear Width)

■ Detectable Warning Surface

↔ Cross Slope (2.0% max.)

← Running Slope (8.3% max.)

↗ Counter Slope (5.0% max.)

↻ Turning Space (X & Y) (2.0% max. / 4' x 4' min.)\*  
\* If constrained at back of walk, min. Y length is 5'.

→ Gutter Flow Slope (as directed)

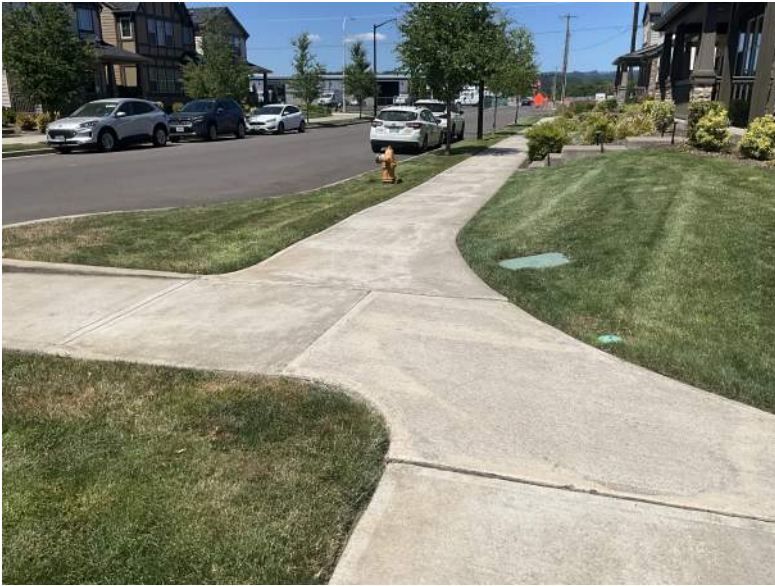
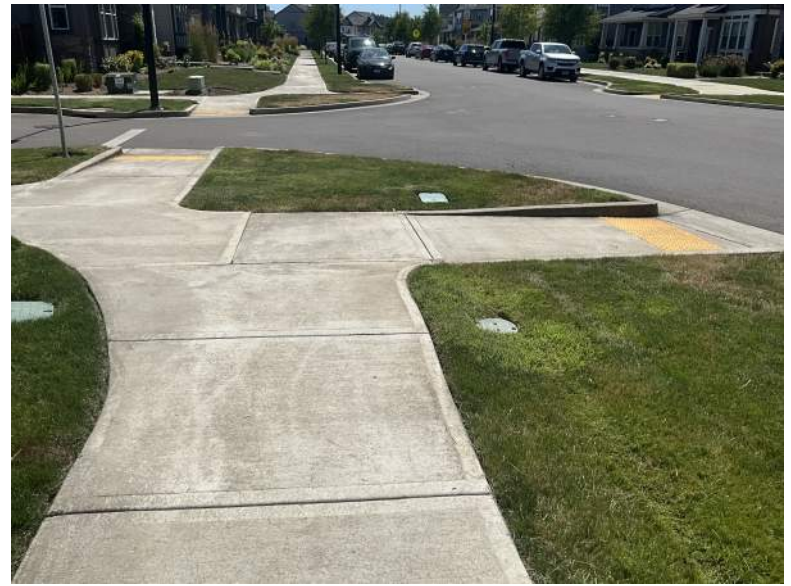
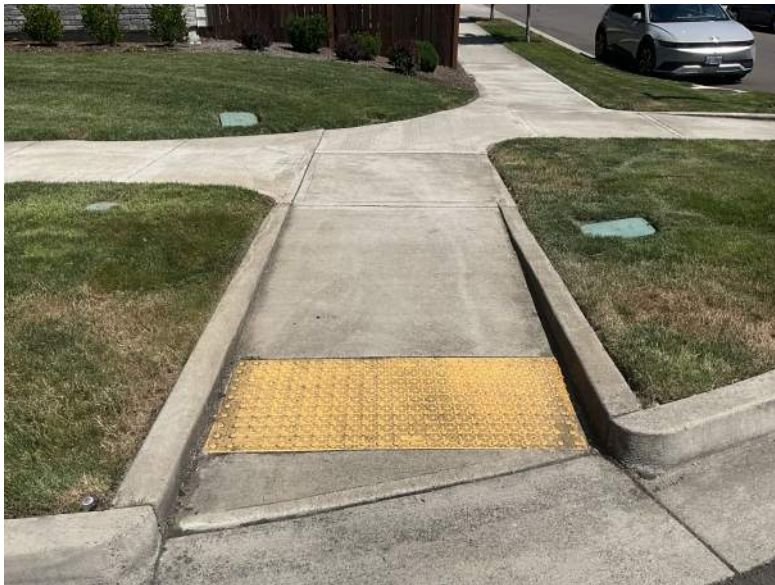
## ADA Curb Ramp Images

TS VL greater than 1/4"
