# ADA Curb Ramp New Construction Inspection Form (Perpendicular)

NW Kaye

24952.54

NW Fair

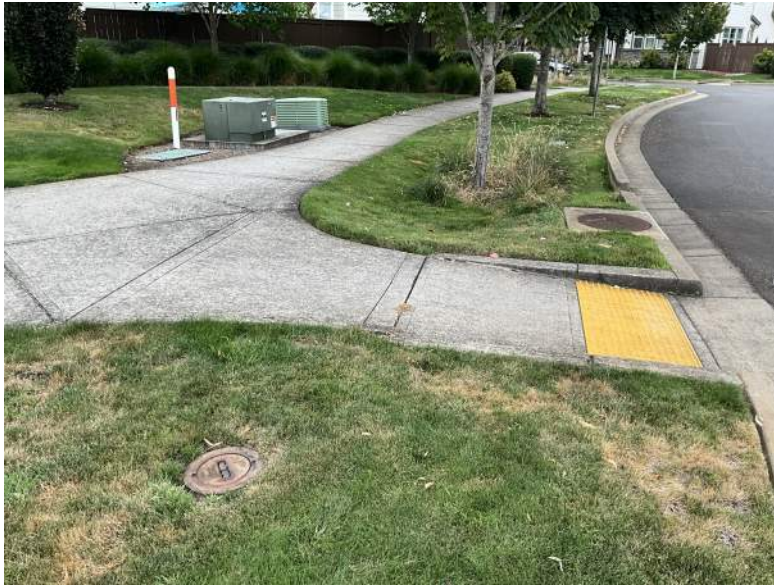
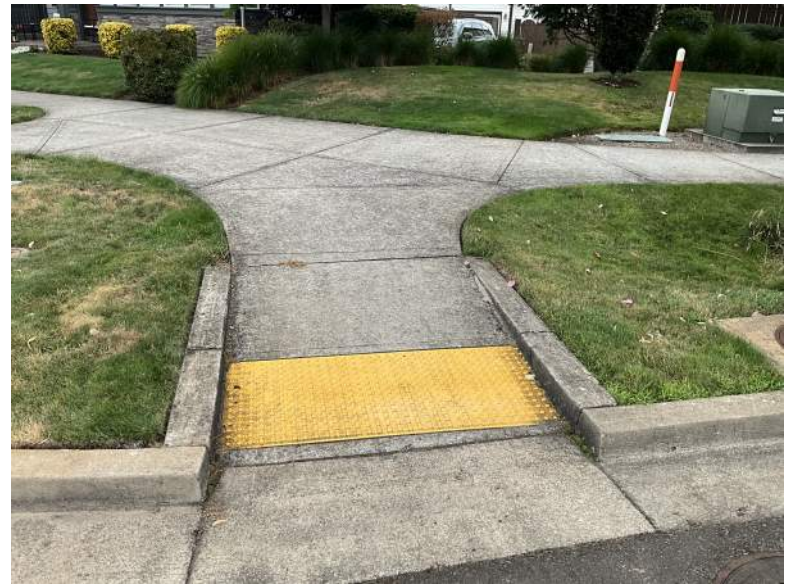
## ADA Curb Ramp Images

IITD, RR1 ICRR
