# ADA Curb Ramp New Construction Inspection Form (Combination)

NW 307th

23886.56

NW Pacific

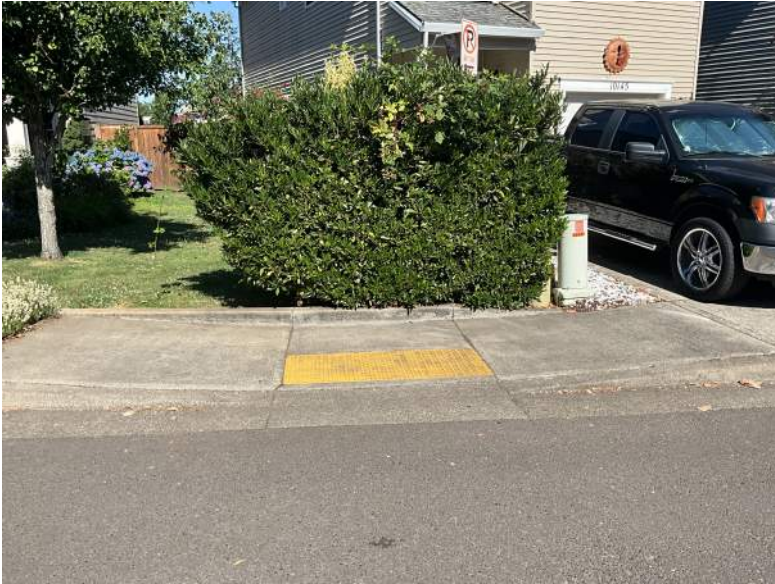
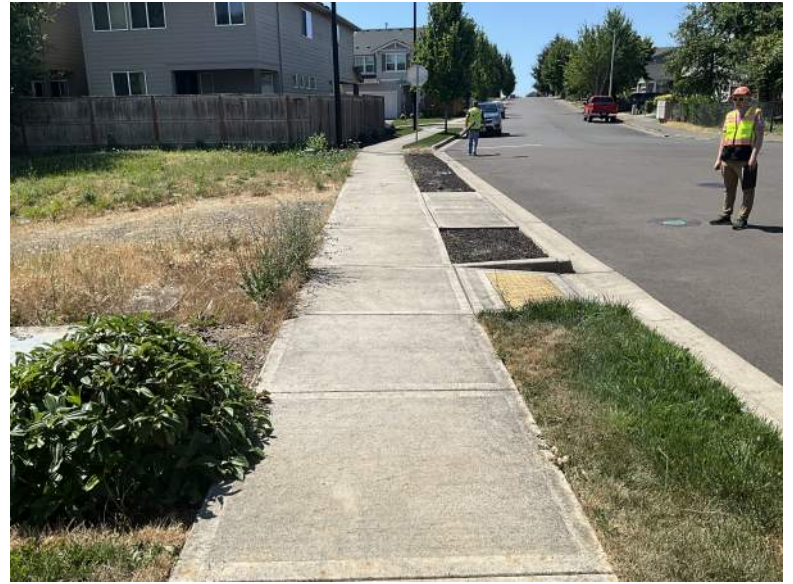
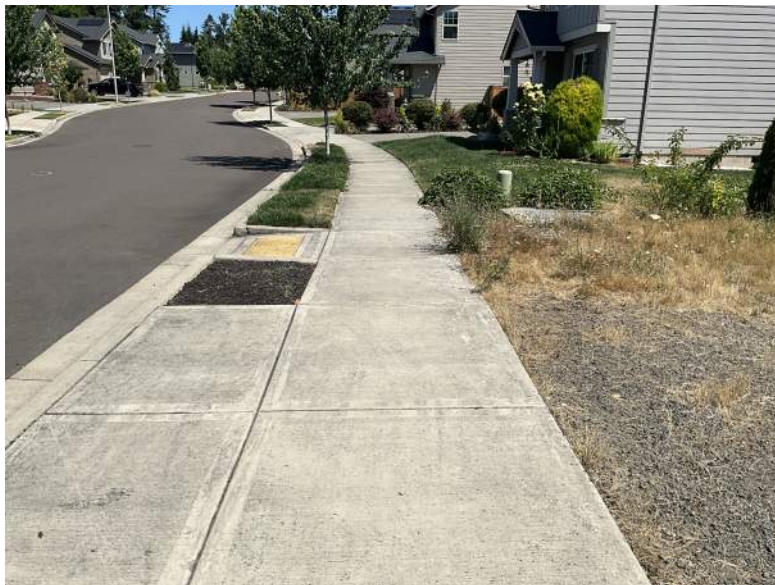
## ADA Curb Ramp Images

Running Slope 1

8.8

Counter Slope (+/-)\*<sup>2</sup>

6.3

Running Slope 2

11.7

3.4

Width X

3.0

Clear Width (feet)
