ADA Curb Ramp New Construction Inspection Form (Perpendicular)

Nw 313th ave

24952.54

Nw. Brookings st

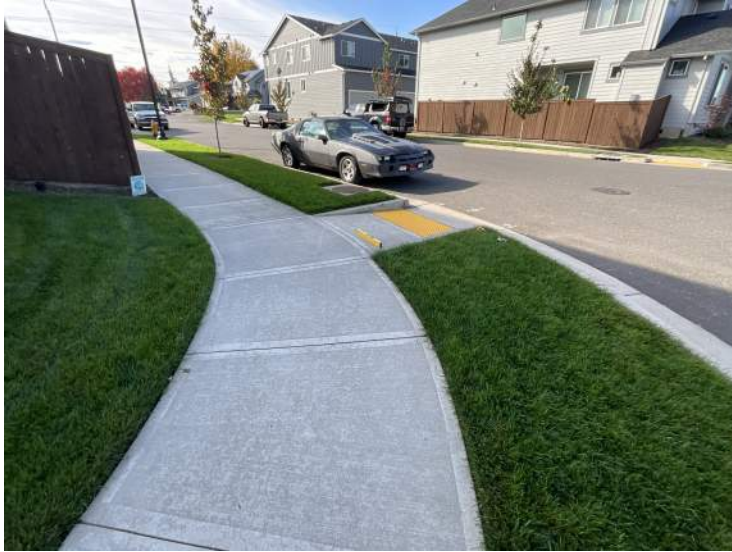
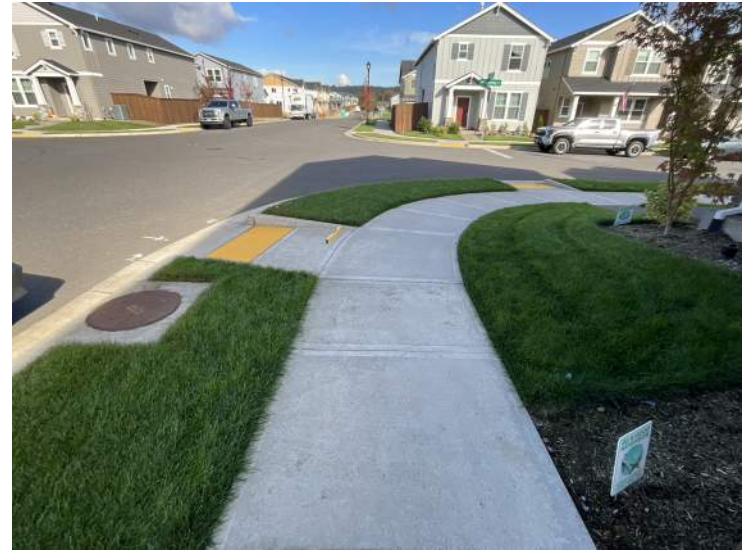
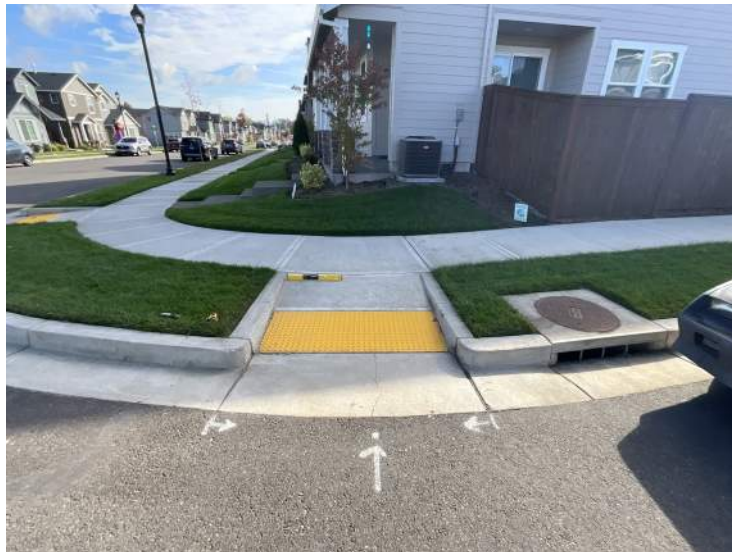
ADA Curb Ramp Images

Cork in curb and gutter.
