ADA Curb Ramp New Construction Inspection Form (Perpendicular)

North-South Road Name

Nw fair st

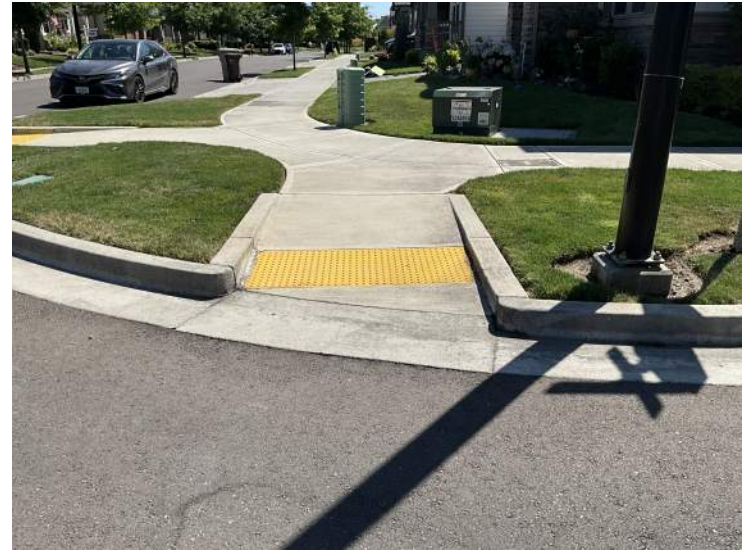
ADA Curb Ramp Images

Tool joint in turn space rr1 icrr
