# ADA Curb Ramp New Construction Inspection Form (Blended Transition)

NW. EMPRESS PL.

24953

NW. NORTH AVE

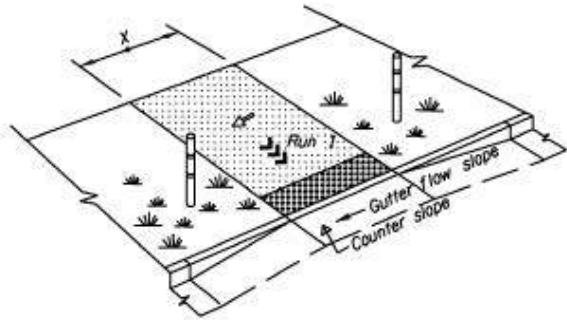
BLENDED TRANSITION (BT)

Pedestrian access route (To measure clear width)

Detectable warning surface

Cross slope (2.0% finish grade max.)

Running slope ( $< 5.0\%$  finish grade max.)  
(If running slope  $\geq 5.0\%$ , this is a curb ramp, not a blended transition.)

Counter slope (5.0% finish grade max.)

Gutter flow slope (as required)

Edge of Gutter Pan

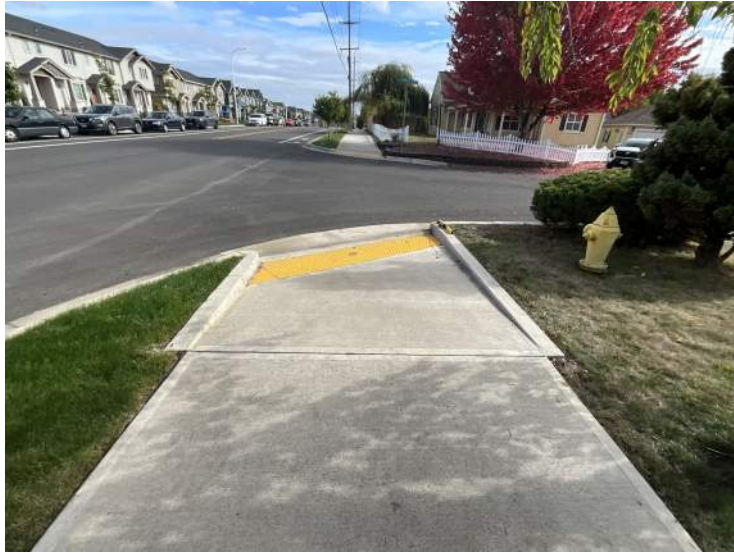
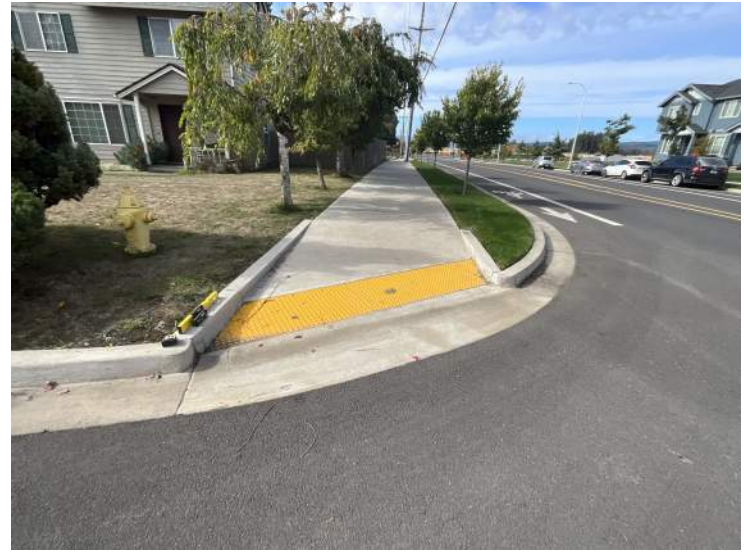
## ADA Curb Ramp Images

Blended Transitions are locations where the pedestrian walkway (which has one direction of travel) and the street crossing intersect at the same plane without the need of a ramp. If the Running Slope is 5.0% or more, the ramp is not a Blended Transition and should be inspected using a different inspection form.
