ADA Curb Ramp New Construction Inspection Form (Combination)

NW Curtis

NW Pacific

Ramp Style **C**

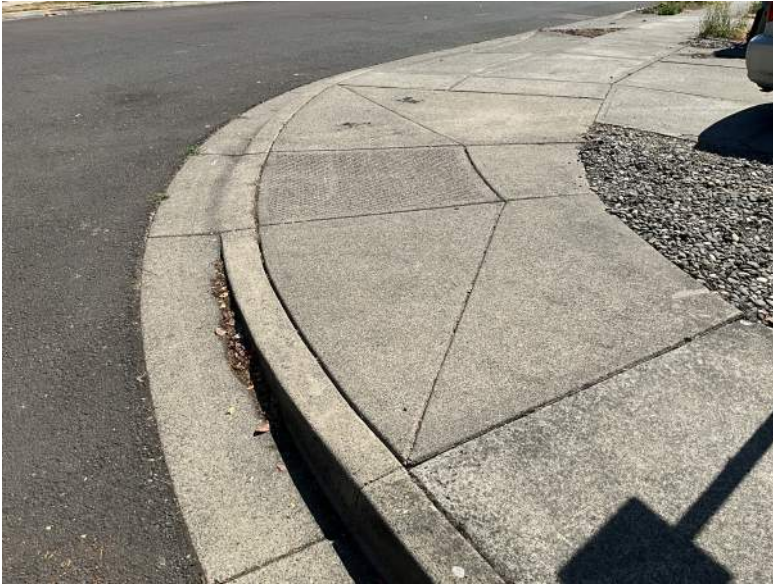
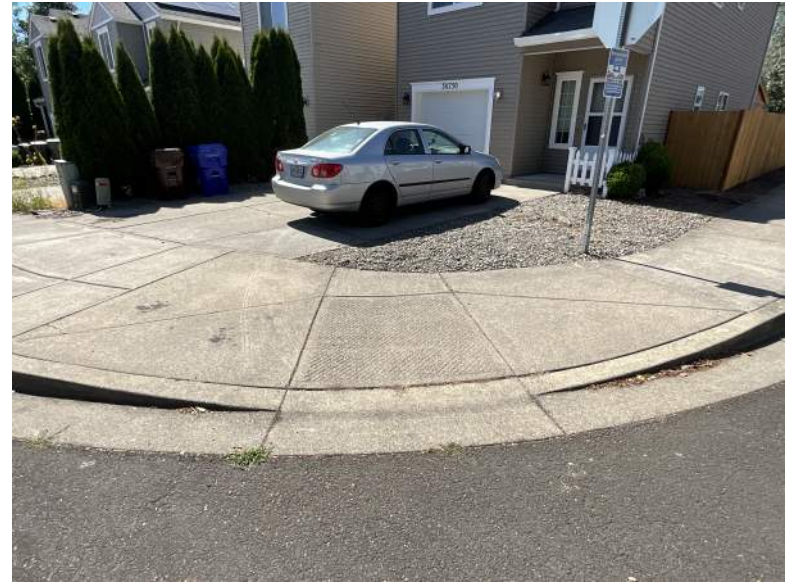
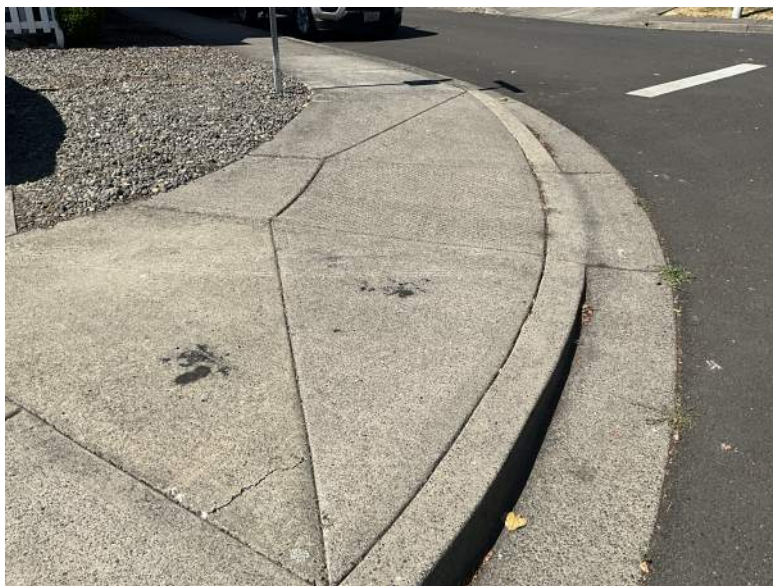
ADA Curb Ramp Images

Ramp run 3-crack in walking path
