ADA Curb Ramp New Construction Inspection Form (Blended Transition)

NW MAIN ST

24953

NW NORTH AVE

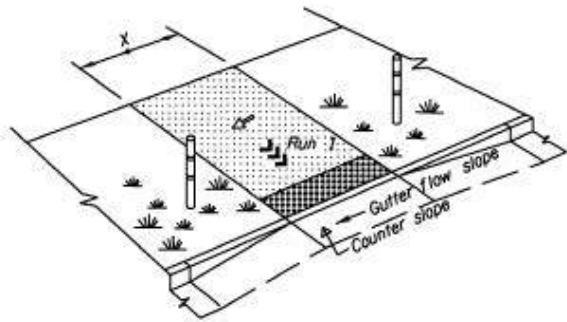
BLENDING TRANSITION (BT)

Pedestrian access route (To measure clear width)

Detectable warning surface

Cross slope (2.0% finish grade max.)

Running slope ($<5.0\%$ finish grade max.)
(If running slope $\geq 5.0\%$, this is a curb ramp, not a blended transition.)

Counter slope (5.0% finish grade max.)

Gutter flow slope (as required)

Edge of Gutter Pan

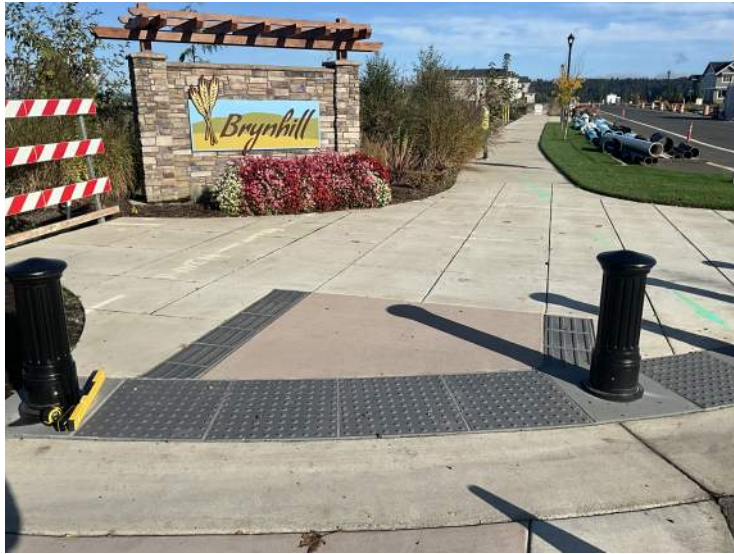
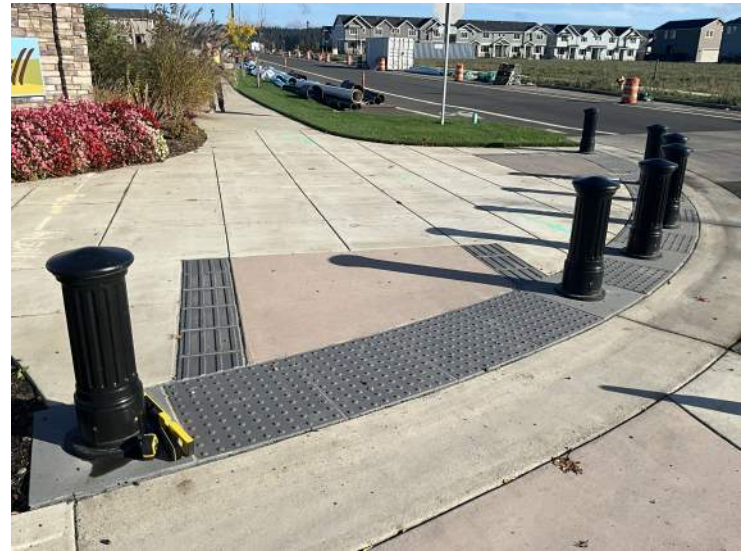
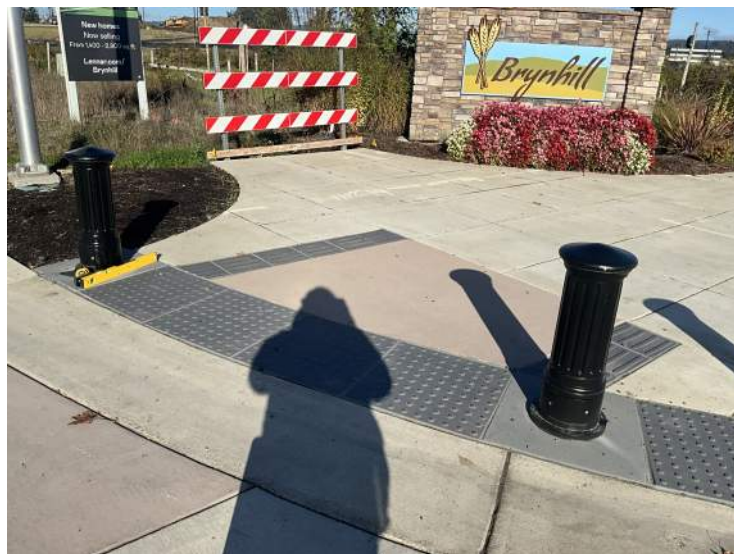
ADA Curb Ramp Images

GFS fail workmanship
