ADA Curb Ramp New Construction Inspection Form (Combination)

NW 307th

23885.56

NW Kaybern

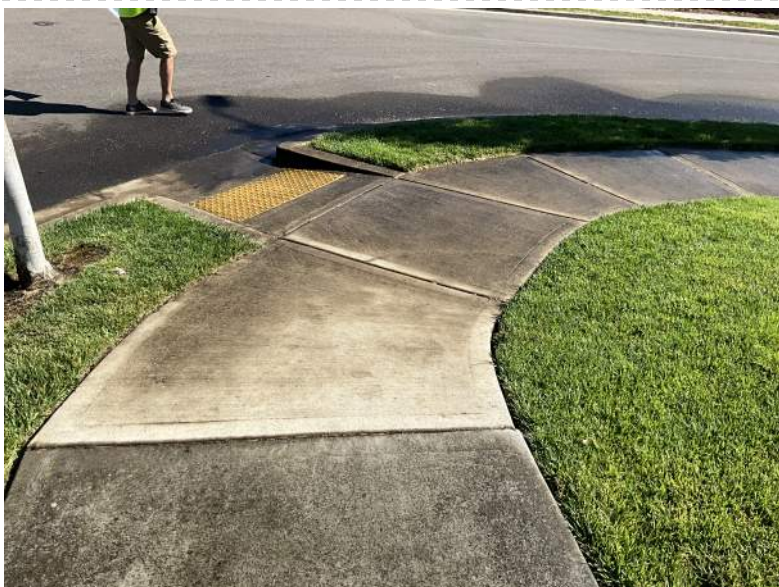
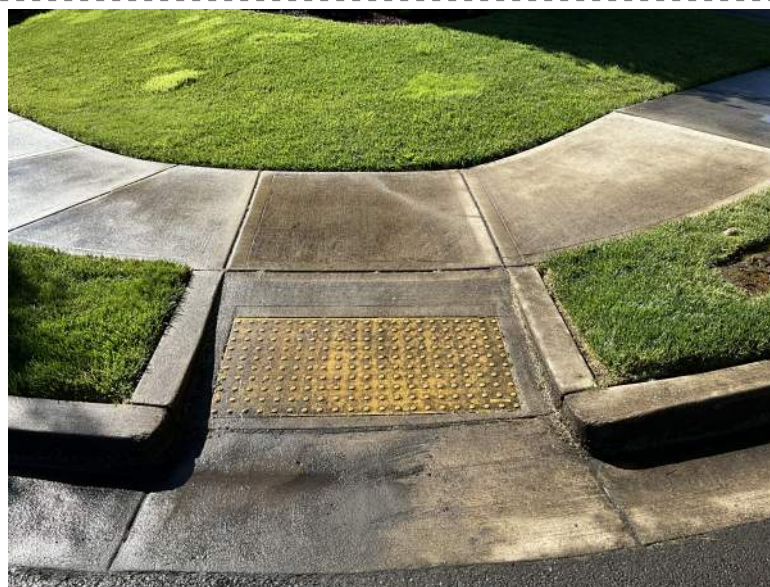
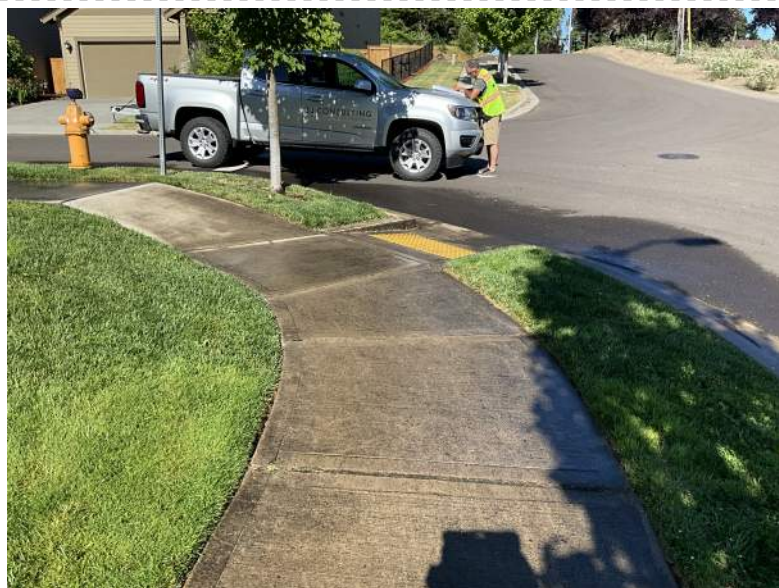
ADA Curb Ramp Images

DWS IITD, TS Large Crack, Puddle in gutter at Ramp
