ADA Curb Ramp New Construction Inspection Form (Perpendicular)

NW 311th Ave

24952.54

NW Moon St

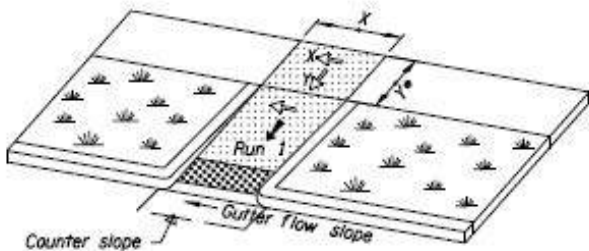
PERPENDICULAR RAMP (PR)

- Pedestrian Access Route (to measure Clear Width)
- Detectable Warning Surface
- Cross Slope (2.0% max.)
- Running Slope (8.3% max.)
- Counter Slope (5.0% max.)
- Turning Space (X & Y) (2.0% max. / 4' x 4' min.)*
- * If constrained at back of walk, min. Y length is 5'.
- Gutter Flow Slope (as directed)

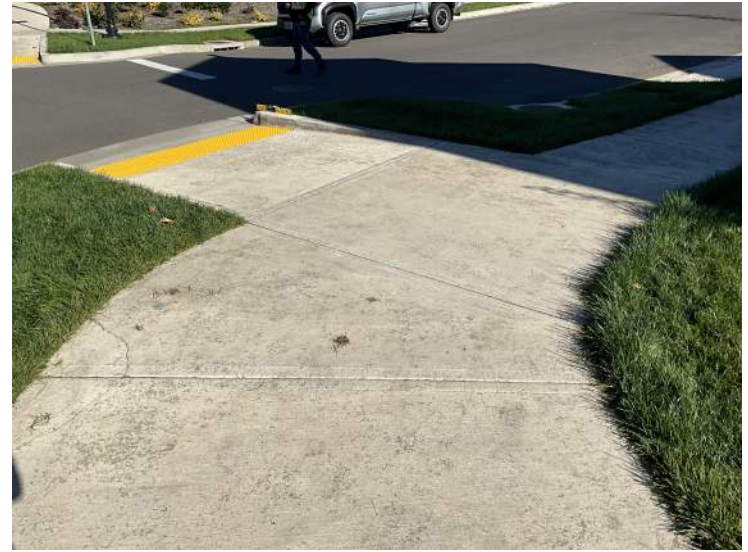
ADA Curb Ramp Images

Poor craftsmanship in gutter area
