ADA Curb Ramp New Construction Inspection Form (Blended Transition)

NW MAIN ST

24953

NW NORTH AVE

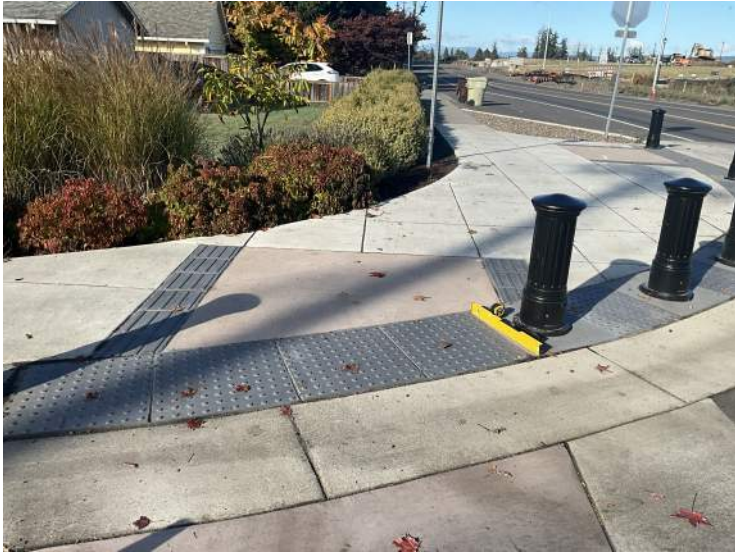
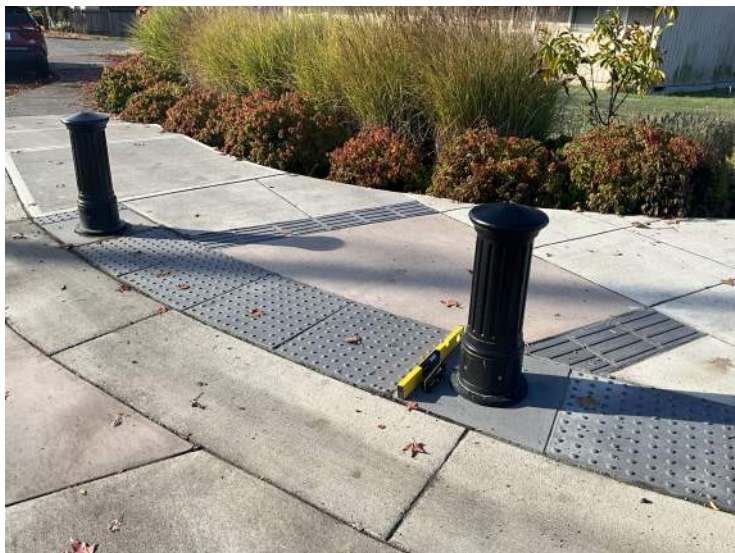
ADA Curb Ramp Images

Blended Transitions are locations where the pedestrian walkway (which has one direction of travel) and the street crossing intersect at the same plane without the need of a ramp. If the Running Slope is 5.0% or more, the ramp is not a Blended Transition and should be inspected using a different inspection form.
