ADA Curb Ramp New Construction Inspection Form (Perpendicular)

Nw 292nd

23885.56

Nw fair

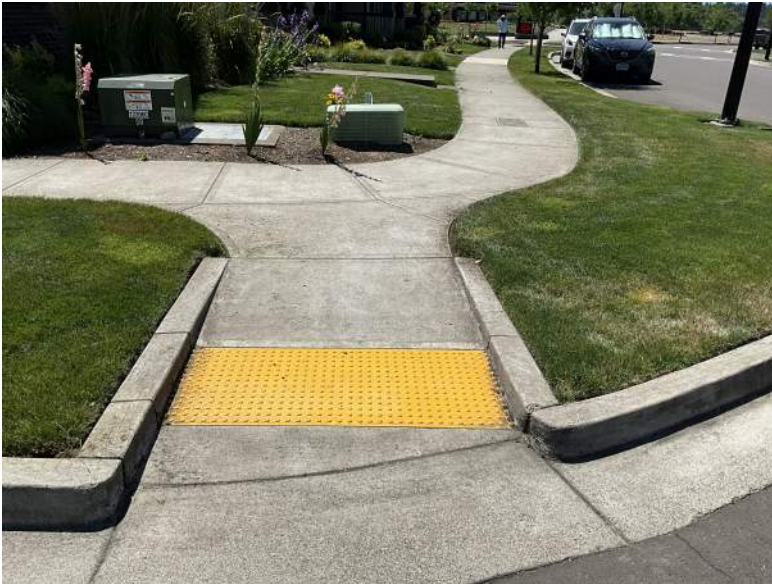
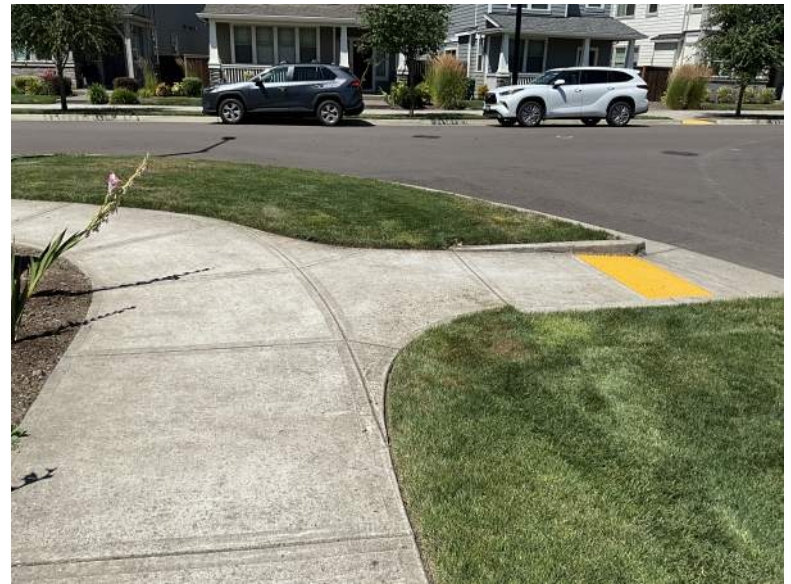
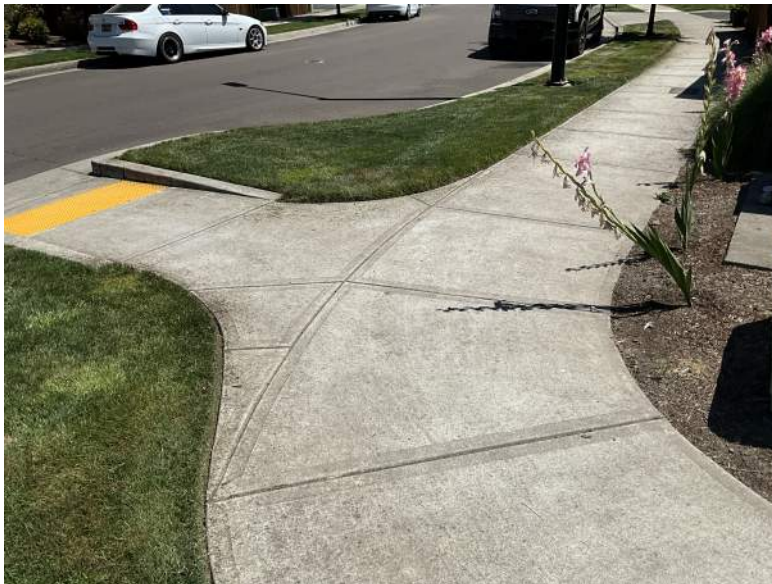
ADA Curb Ramp Images

Tool joints in TS
