ADA Curb Ramp New Construction Inspection Form (Combination)

NW 307th Ave

23885.56

NW Highland Ct

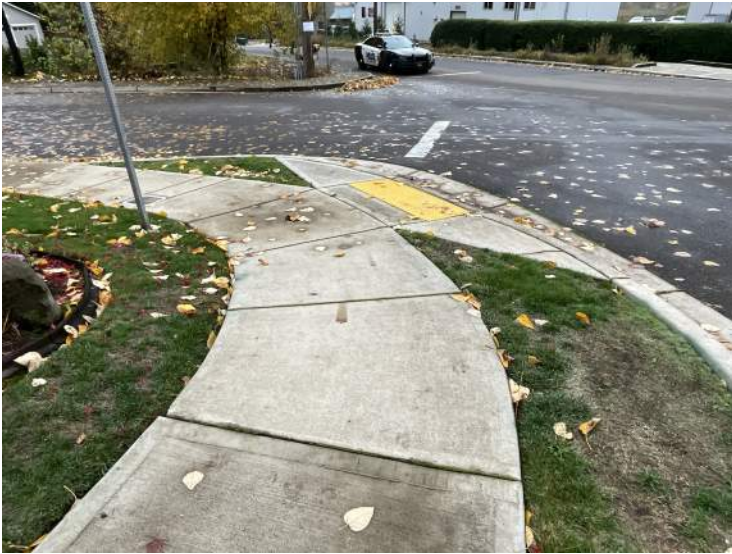
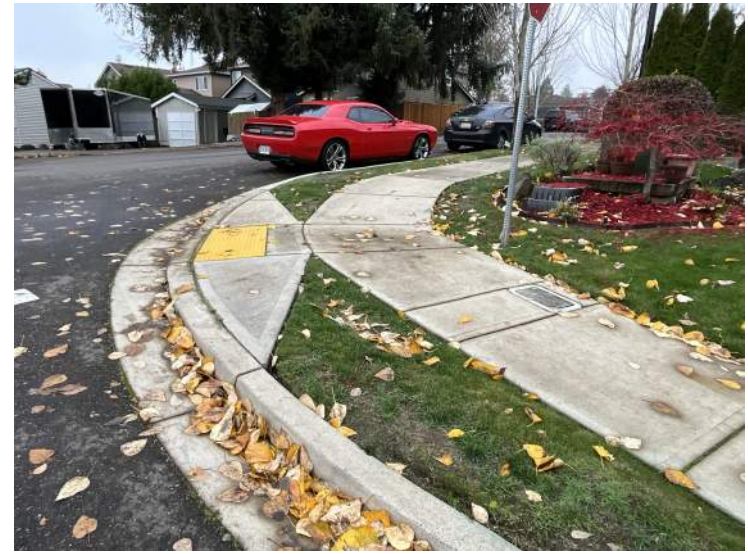
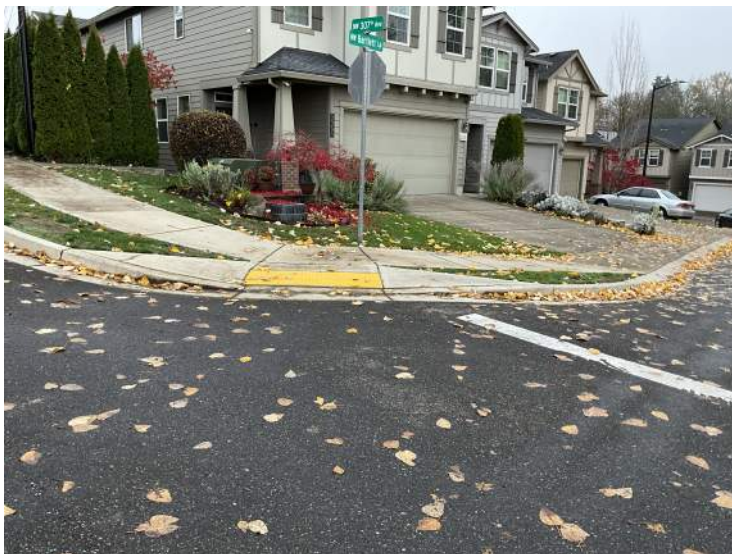
ADA Curb Ramp Images

7.4

2.9

9.98

5.7

2.8

17.5

3.55

3.3

13.1
