ADA Curb Ramp New Construction Inspection Form (Perpendicular)

311th North-South Road Name 24952.54 Project No. Sheet No. Intersection No. Kaybern East-West Road Name

Ramp Style PR

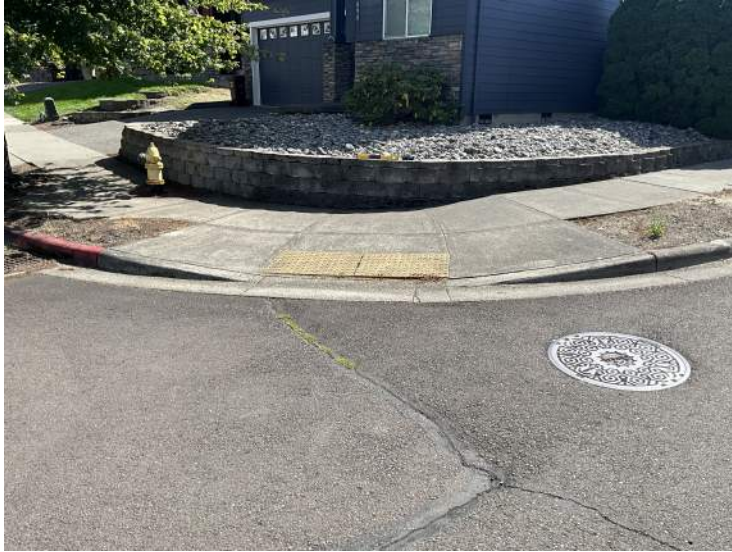
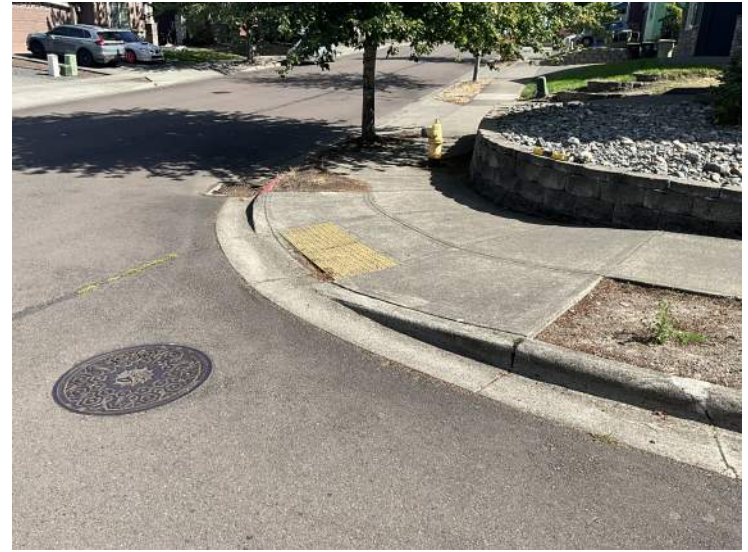
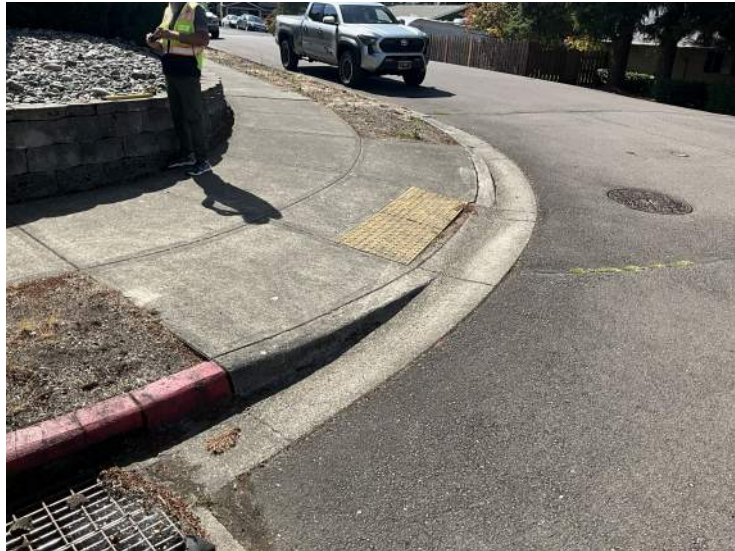
ADA Curb Ramp Images

IITD, gt2. Lip at front of TD
