ADA Curb Ramp New Construction Inspection Form (Combination)

NW Curtis

NW Pacific

3J Consulting

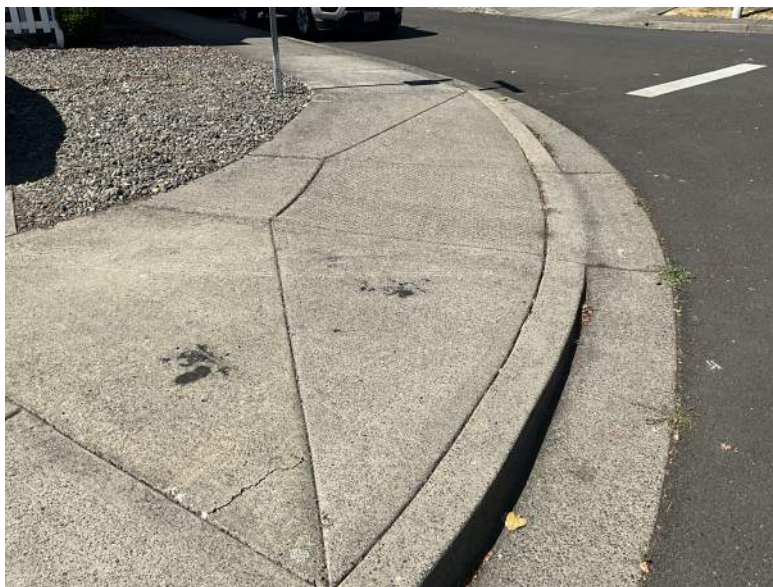
ADA Curb Ramp Images

Ramp run 3-crack in walking path
