ADA Curb Ramp New Construction Inspection Form (Perpendicular)

NW Main

Project No.

NW Lenox

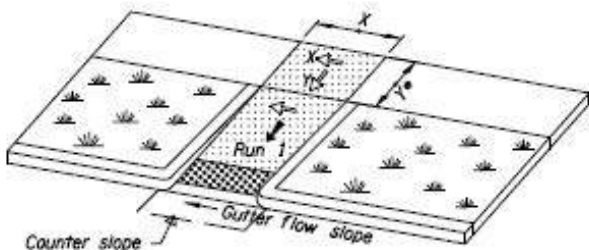
PERPENDICULAR RAMP (PR)

Pedestrian Access Route (to measure Clear Width)

Detectable Warning Surface

Cross Slope (2.0% max.)

Running Slope (8.3% max.)

Counter Slope (5.0% max.)

Turning Space (X & Y) (2.0% max. / 4' x 4' min.)*
* If constrained at back of walk, min. Y length is 5'.

Gutter Flow Slope (as directed)

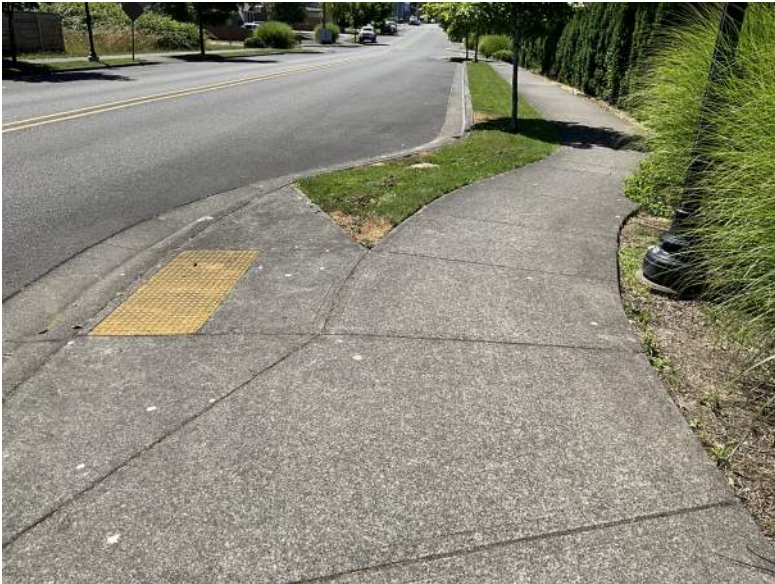
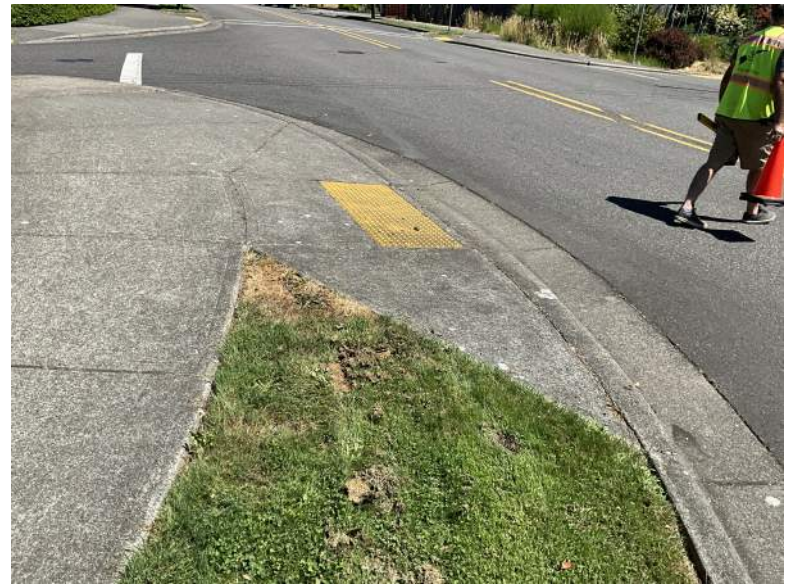
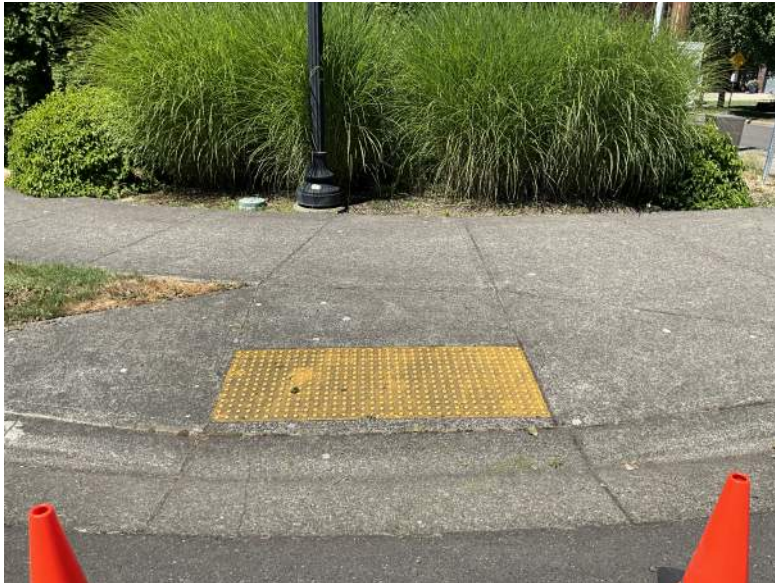
ADA Curb Ramp Images

DWS IITD Fails RR 1
