# ADA Curb Ramp New Construction Inspection Form (Combination)

Nw 287

24952.54

Nw mays

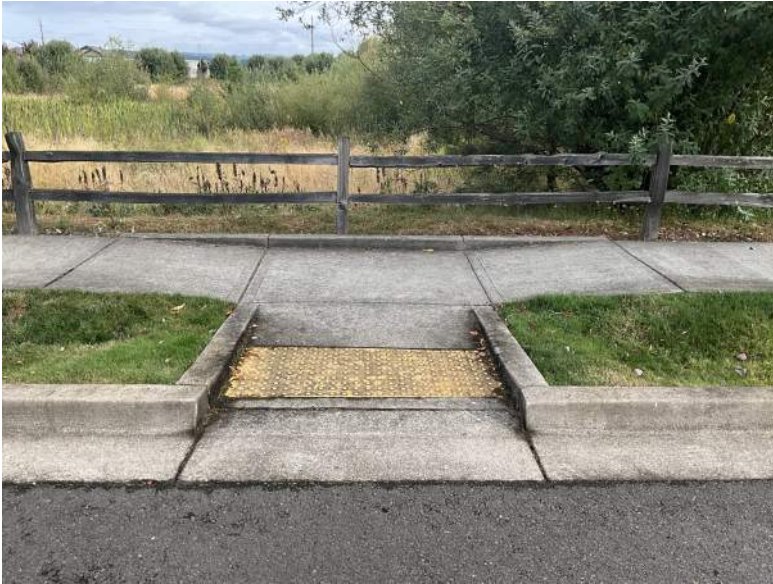
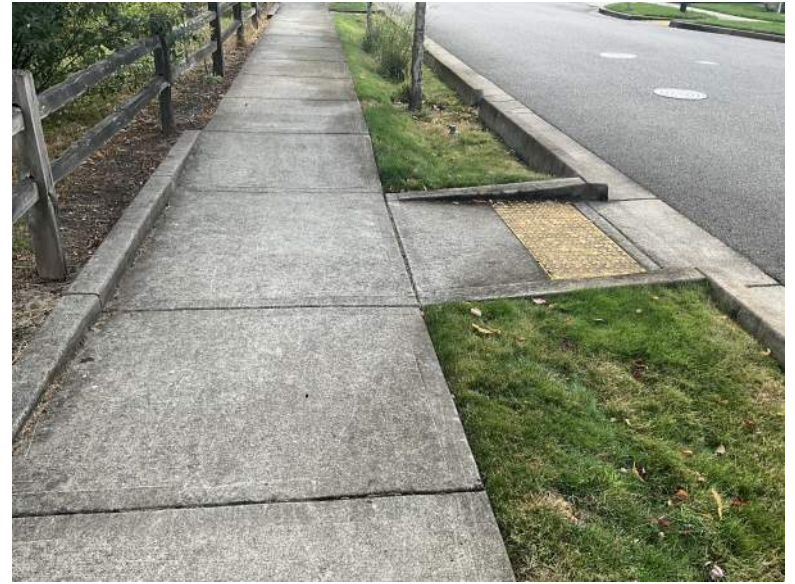
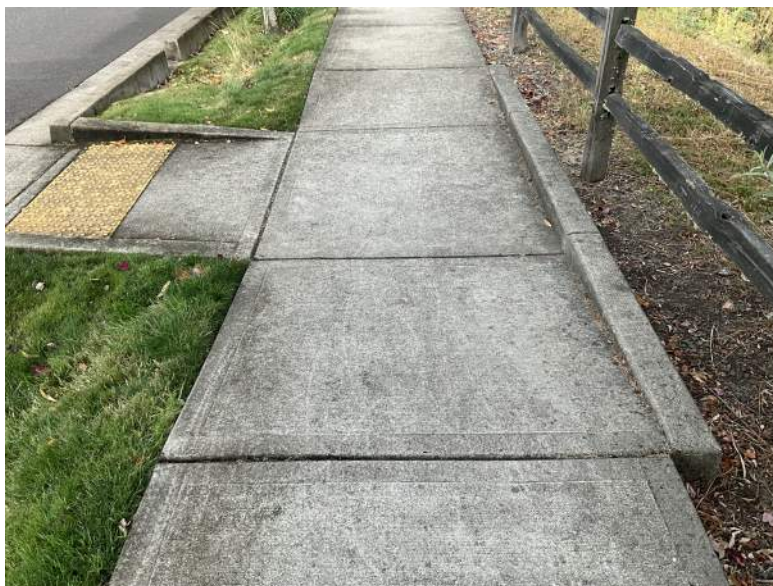
## ADA Curb Ramp Images

IITD RR1 fail
