ADA Curb Ramp New Construction Inspection Form (Perpendicular)

NW Cami PI

24952.54

NW North Ave

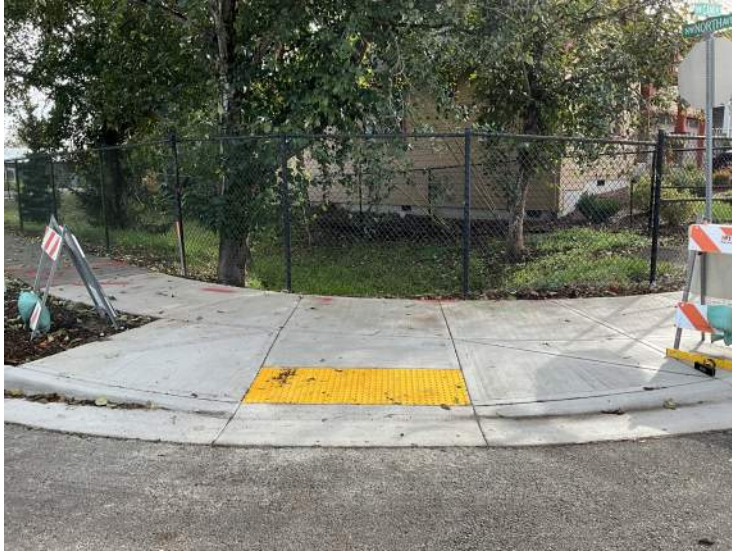
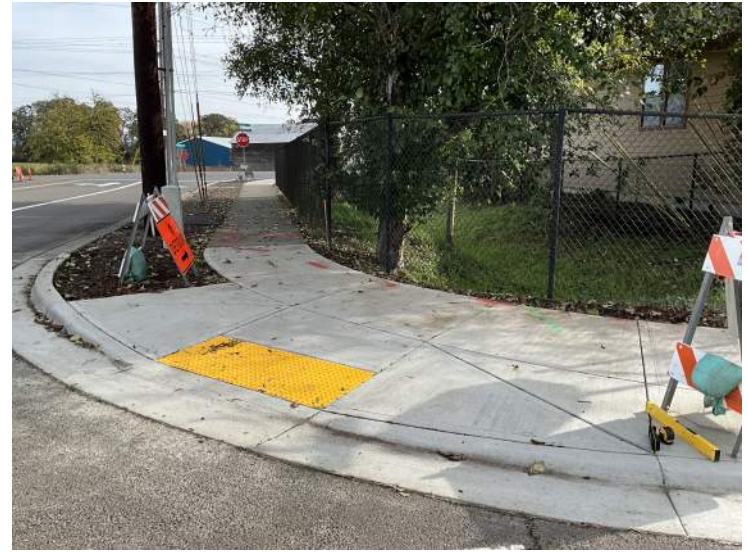
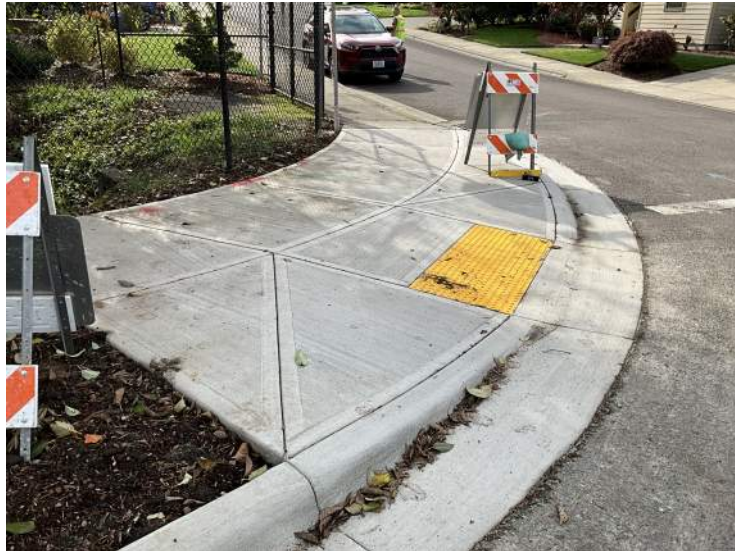
ADA Curb Ramp Images

Counter Slope (+/-) *2

5.4

>|5.0%|
