# ADA Curb Ramp New Construction Inspection Form (Perpendicular)

NW Main

23885.56

NW Lenox

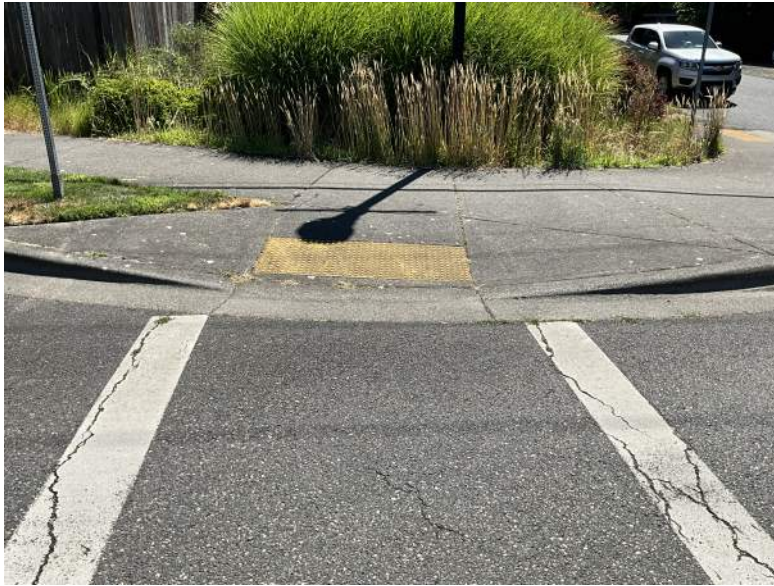
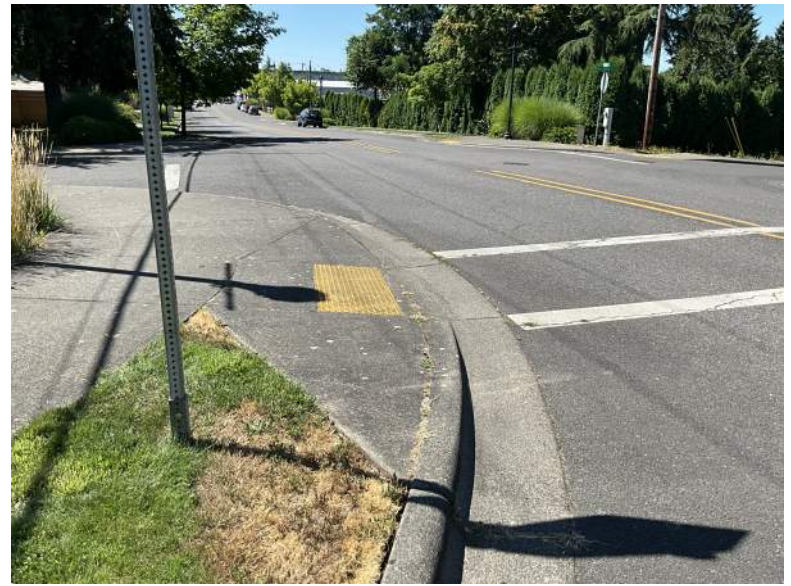
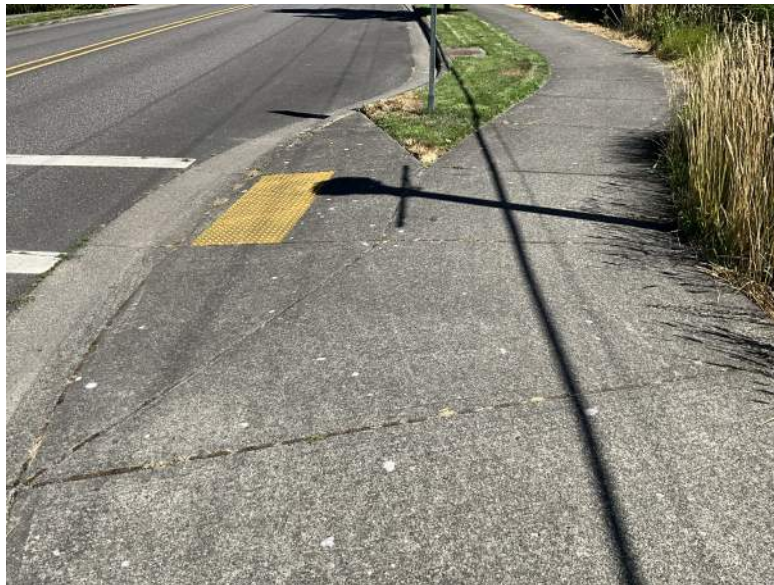
## ADA Curb Ramp Images

DWS IITD Fails RR 1
