ADA Curb Ramp New Construction Inspection Form (Perpendicular)

24952.54

Timeric

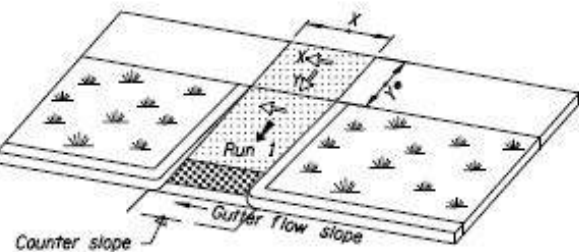
PERPENDICULAR RAMP (PR)

Pedestrian Access Route (to measure Clear Width)

Detectable Warning Surface

Cross Slope (2.0% max.)

Running Slope (8.3% max.)

Counter Slope (5.0% max.)

Turning Space (X & Y) (2.0% max. / 4' x 4' min.)*
* If constrained at back of walk, min. Y length is 5'.

Gutter Flow Slope (as directed)

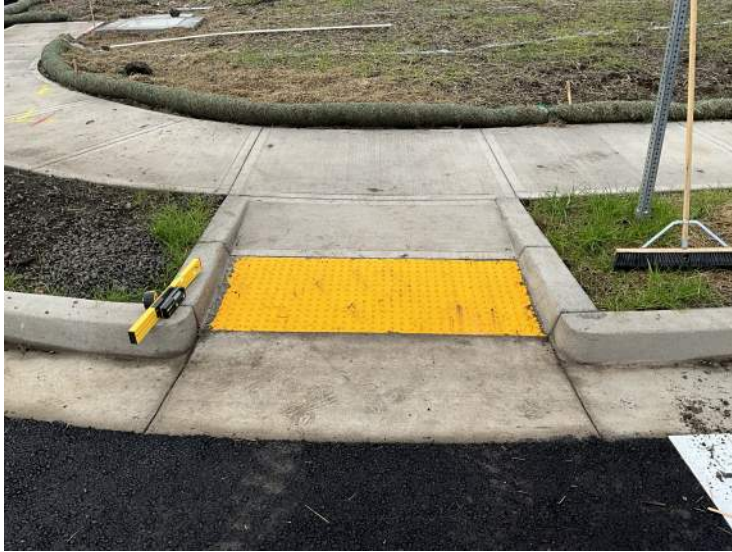
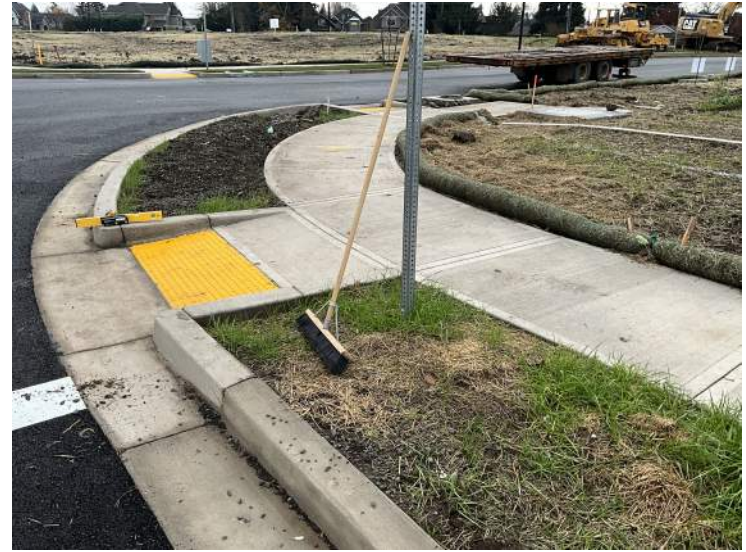
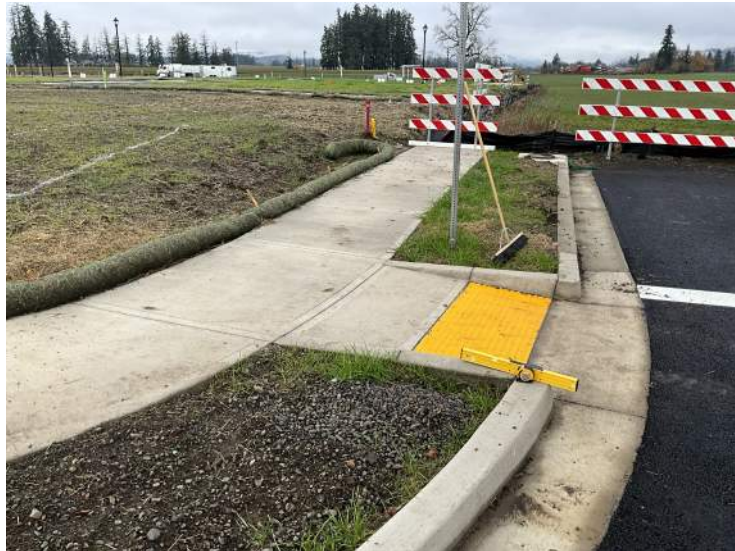
ADA Curb Ramp Images

5.9

CS FAIL NORTH END
