# ADA Curb Ramp New Construction Inspection Form (Perpendicular)

NW TIMERIC DR

24953

NW TUREL DR

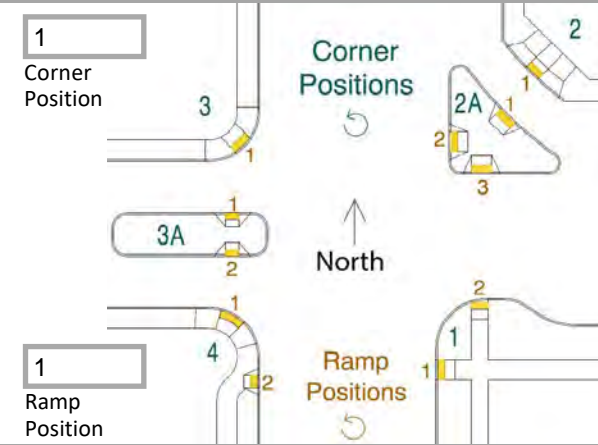
## PERPENDICULAR RAMP (PR)

- Pedestrian Access Route (to measure Clear Width)
- Detectable Warning Surface
- Cross Slope (2.0% max.)
- Running Slope (8.3% max.)
- Counter Slope (5.0% max.)
- Turning Space (X & Y) (2.0% max. / 4' x 4' min.)\*
- \* If constrained at back of walk, min. Y length is 5'.
- Gutter Flow Slope (as directed)
