ADA Curb Ramp New Construction Inspection Form (Blended Transition)

NW. EMPRESS PL.

24953

NW. NORTH AVE

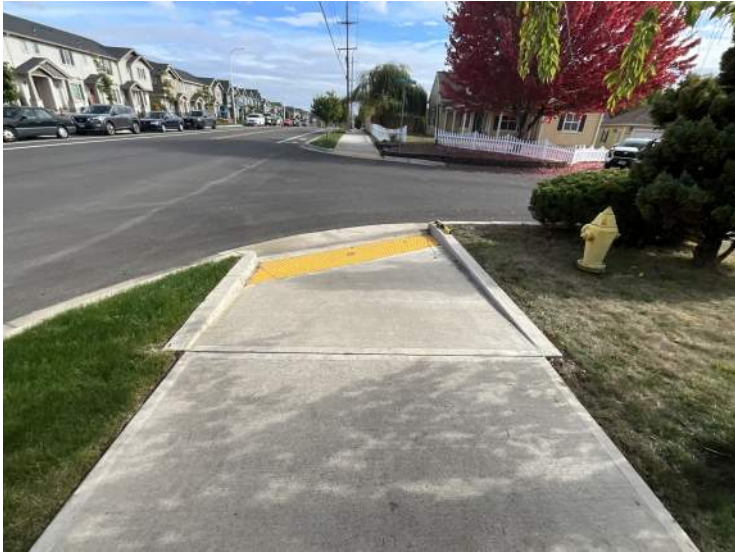
ADA Curb Ramp Images

7.6

2.2

Blended Transitions are locations where the pedestrian walkway (which has one direction of travel) and the street crossing intersect at the same plane without the need of a ramp. If the Running Slope is 5.0% or more, the ramp is not a Blended Transition and should be inspected using a different inspection form.
