# ADA Curb Ramp New Construction Inspection Form (Blended Transition)

NW MAIN ST

29453

NW NORTH AVE

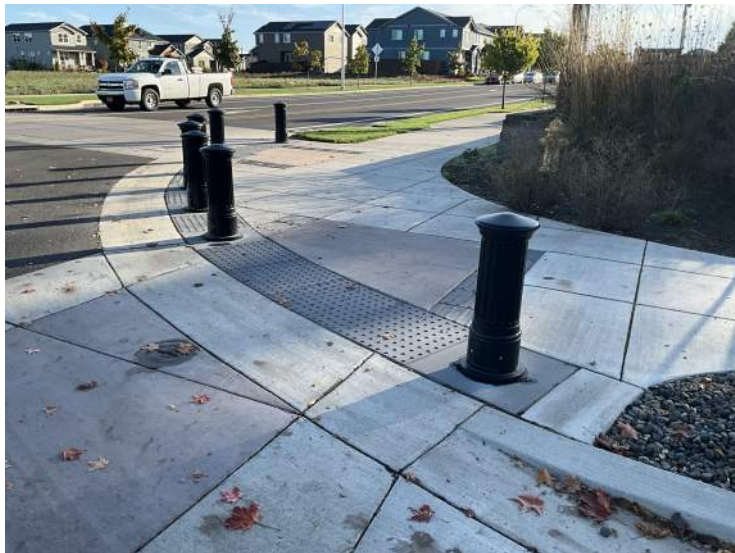
## ADA Curb Ramp Images

Blended Transitions are locations where the pedestrian walkway (which has one direction of travel) and the street crossing intersect at the same plane without the need of a ramp. If the Running Slope is 5.0% or more, the ramp is not a Blended Transition and should be inspected using a different inspection form.
