ADA Curb Ramp New Construction Inspection Form (Perpendicular)

Nw 287

Project No.

Nw may

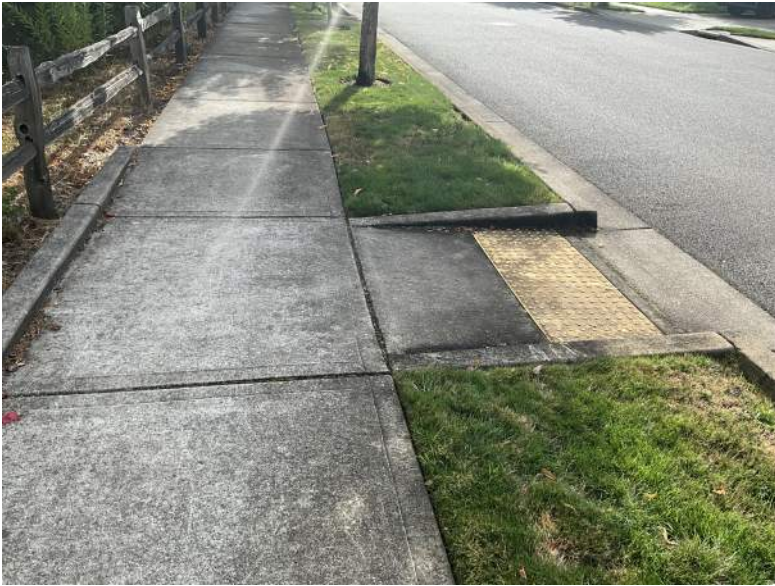
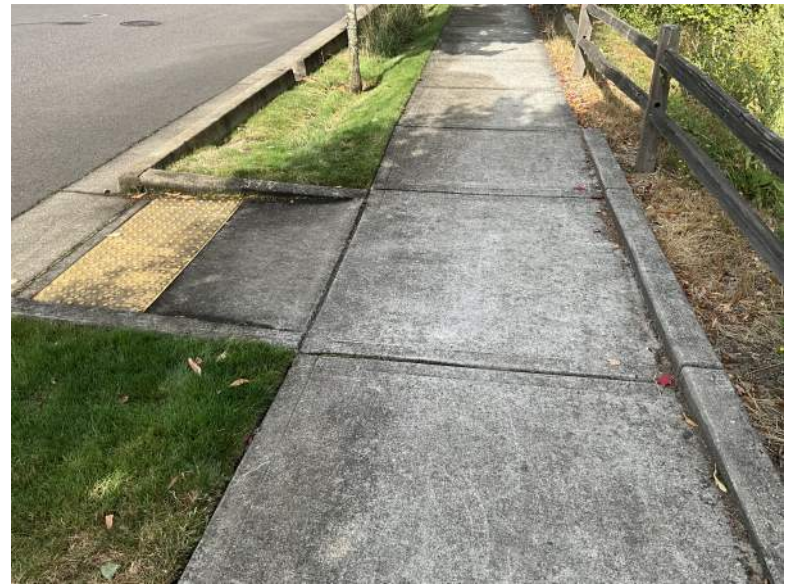
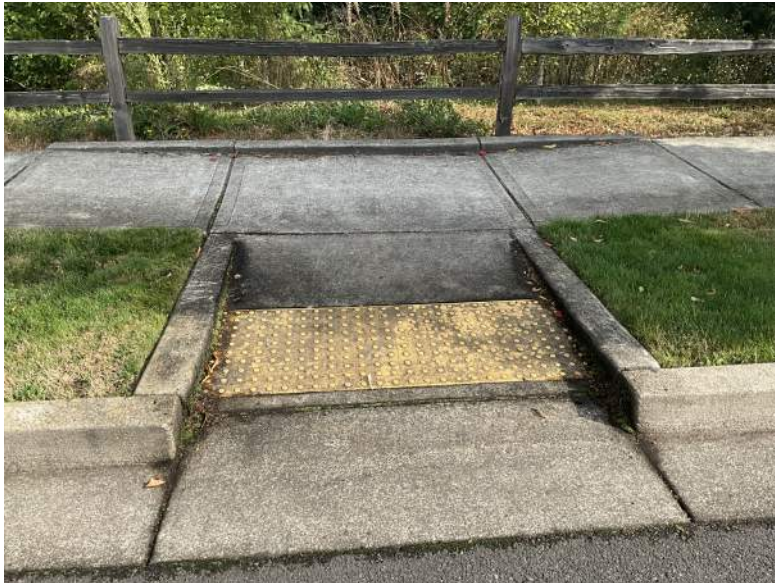
ADA Curb Ramp Images

IITD RR1 fail
