# ADA Curb Ramp New Construction Inspection Form (Perpendicular)

Nw 314th Ave.

24952.54

NW Timeric Dr

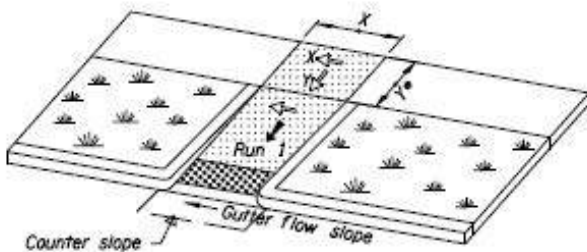
## PERPENDICULAR RAMP (PR)

Pedestrian Access Route (to measure Clear Width)

Detectable Warning Surface

Cross Slope (2.0% max.)

Running Slope (8.3% max.)

Counter Slope (5.0% max.)

Turning Space (X & Y) (2.0% max. / 4' x 4' min.)\*  
\* If constrained at back of walk, min. Y length is 5'.

Gutter Flow Slope (as directed)
