ADA Curb Ramp New Construction Inspection Form (Perpendicular)

Nw 288 ter

Project No.

Nw carver st

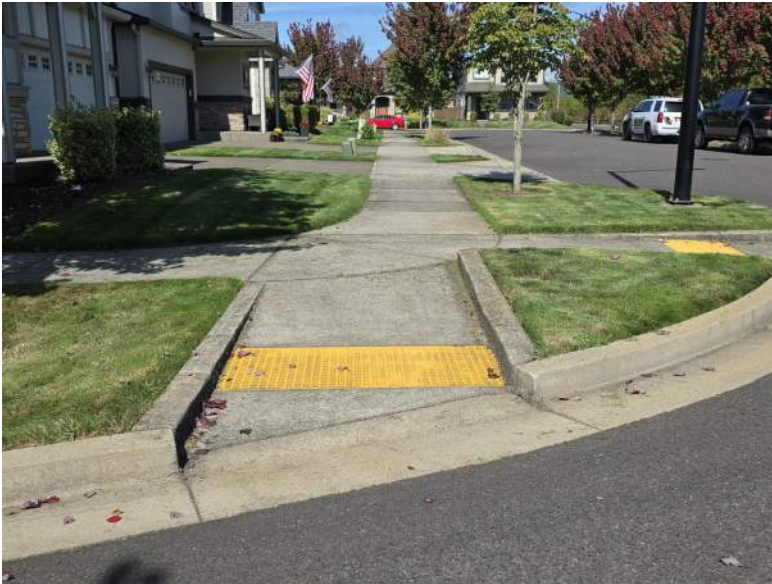
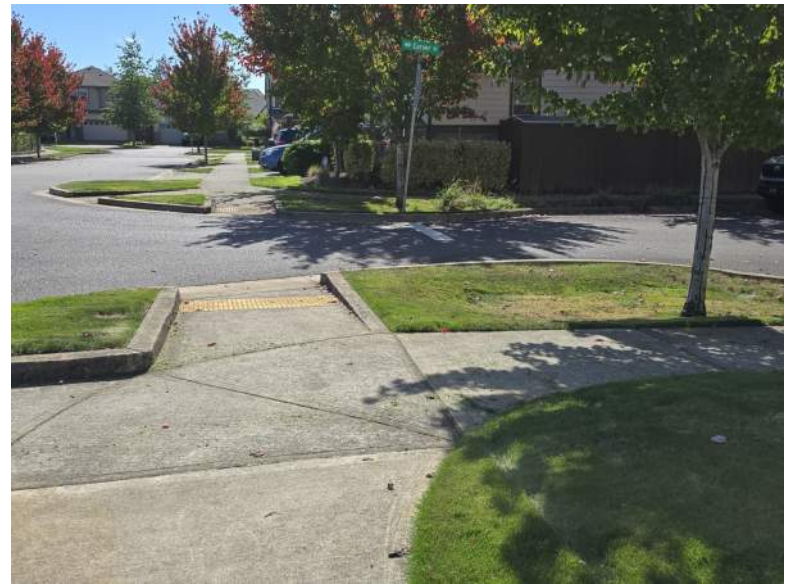
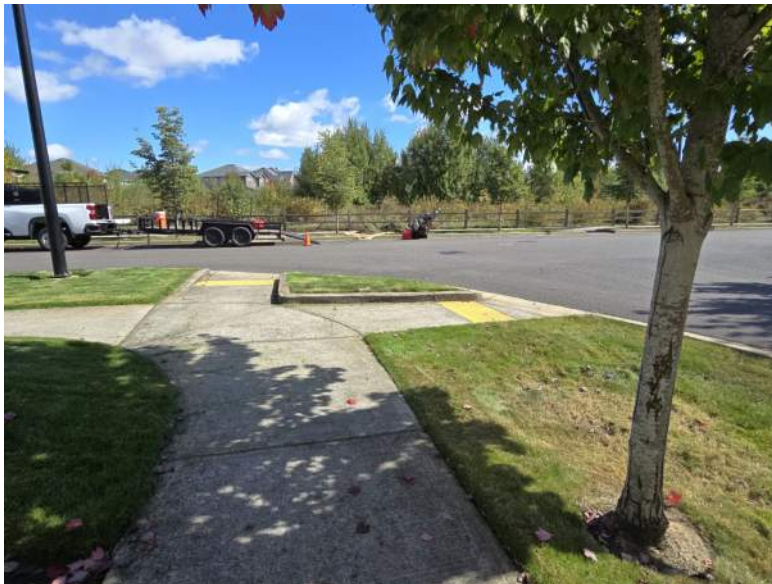
ADA Curb Ramp Images

Too joints in turn space
