ADA Curb Ramp New Construction Inspection Form (Perpendicular)

Nw 315 th ave

24952.54

Nw Yorkshire st

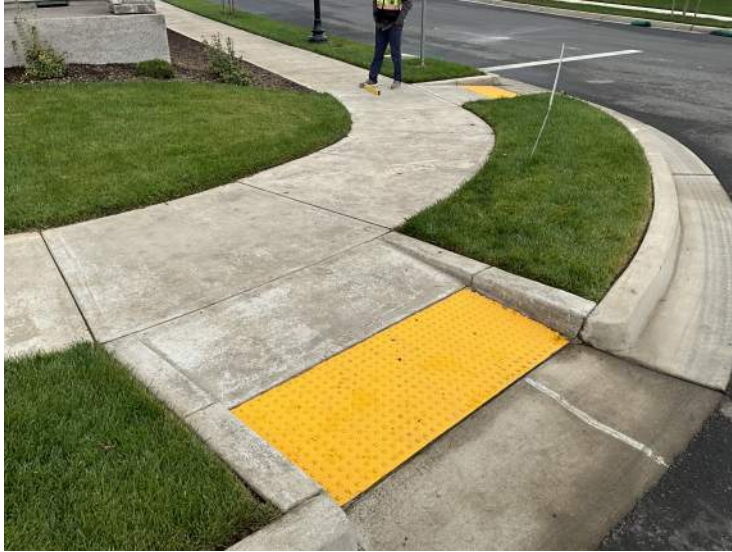
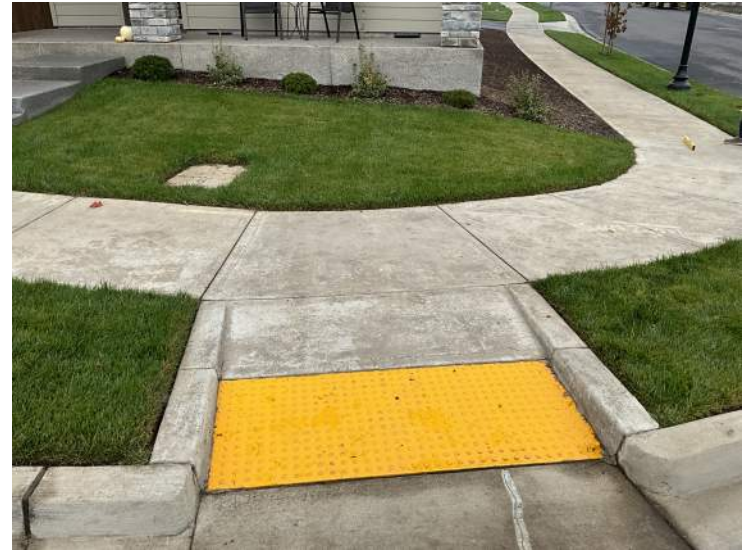
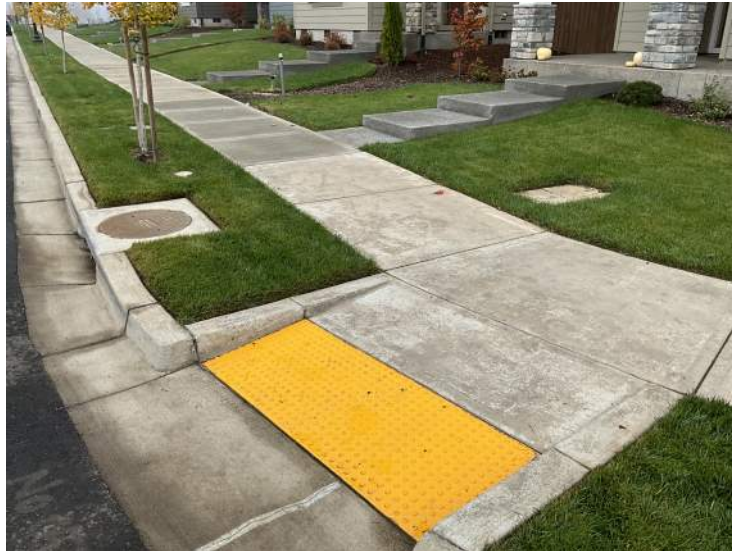
ADA Curb Ramp Images

Crack thru curb and gutter
