ADA Curb Ramp New Construction Inspection Form (Perpendicular)

Nw 291 st

23885.56

Nw king ave

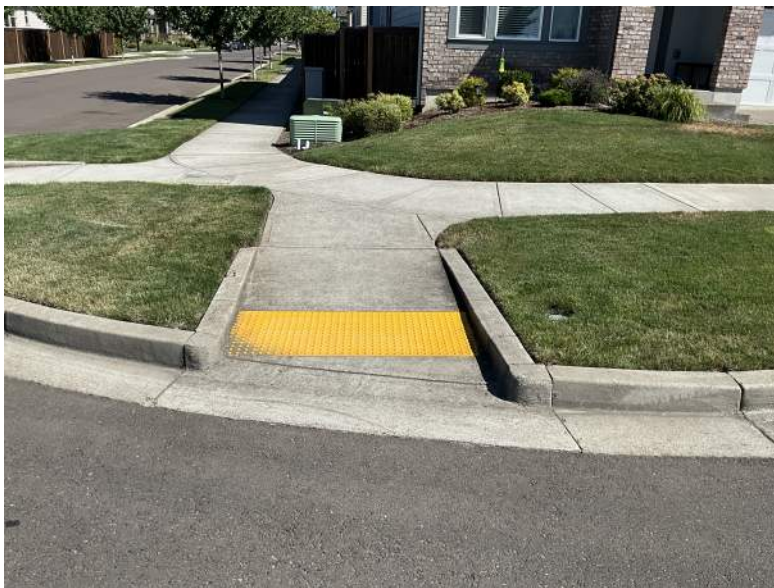
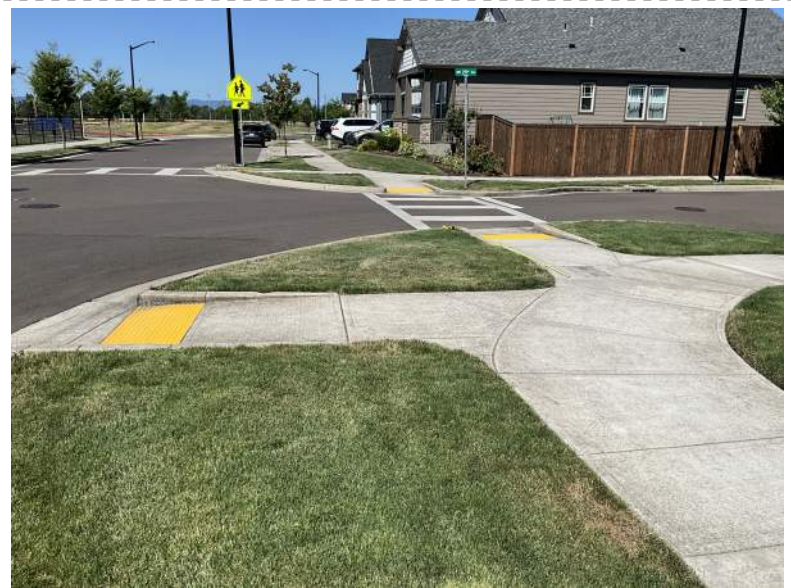
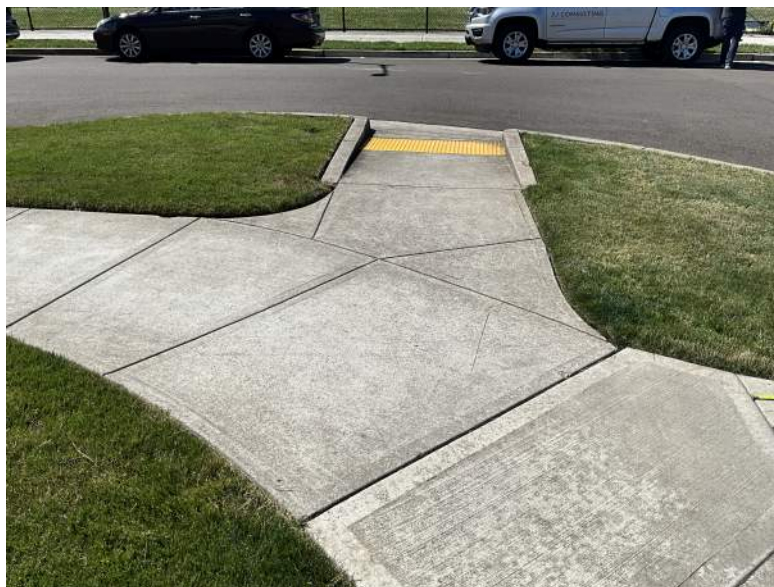
ADA Curb Ramp Images

RR1 ICRR TS tool joints
