ADA Curb Ramp New Construction Inspection Form (Perpendicular)

311th

East-West Road Name

3J Consulting

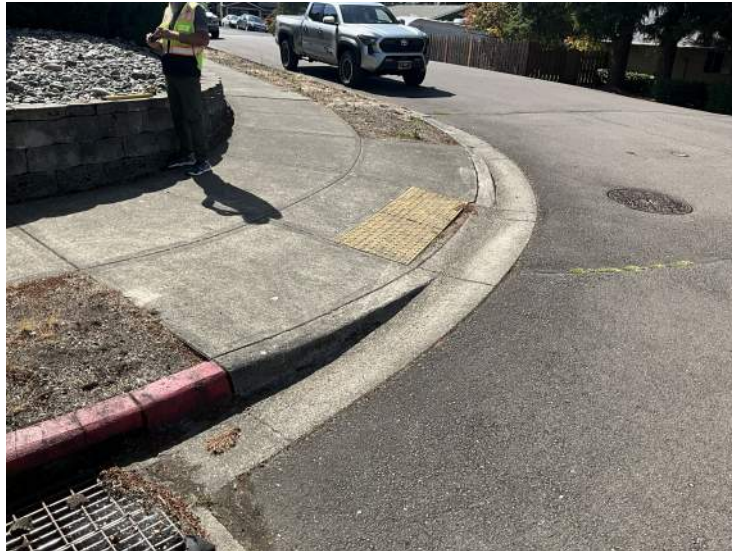
ADA Curb Ramp Images

IITD, gt2. Lip at front of TD
