ADA Curb Ramp New Construction Inspection Form (Perpendicular)

Nw 291 ave

Project No.

Nw carver st

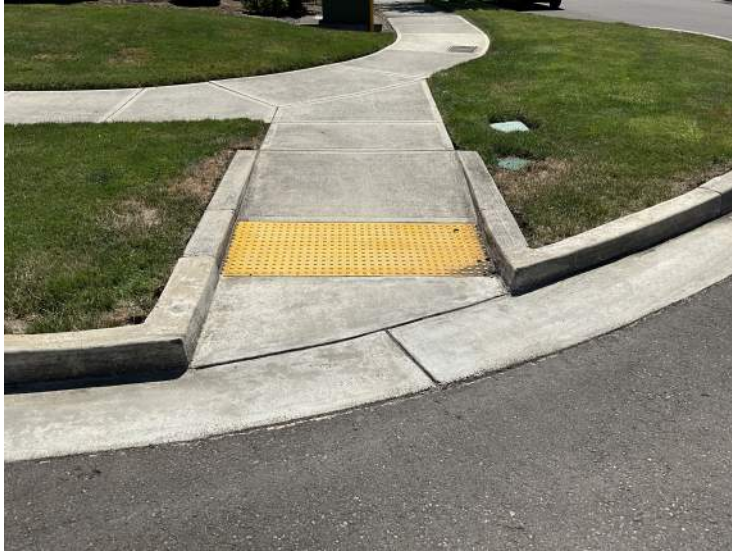
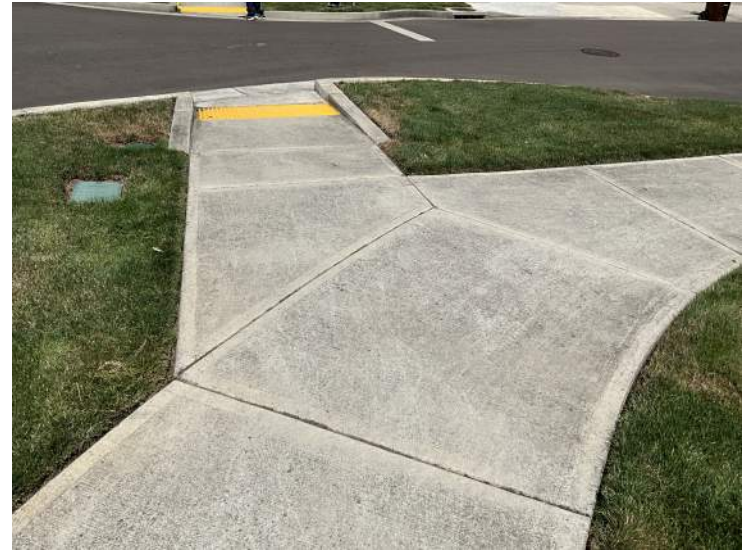
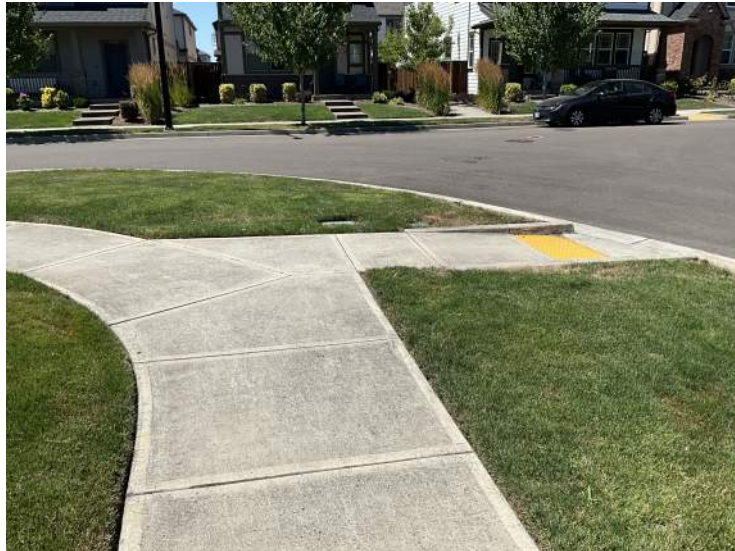
ADA Curb Ramp Images

Rr1 icrr
