ADA Curb Ramp New Construction Inspection Form (Perpendicular)

NW Main

23885.56

NW Lenox

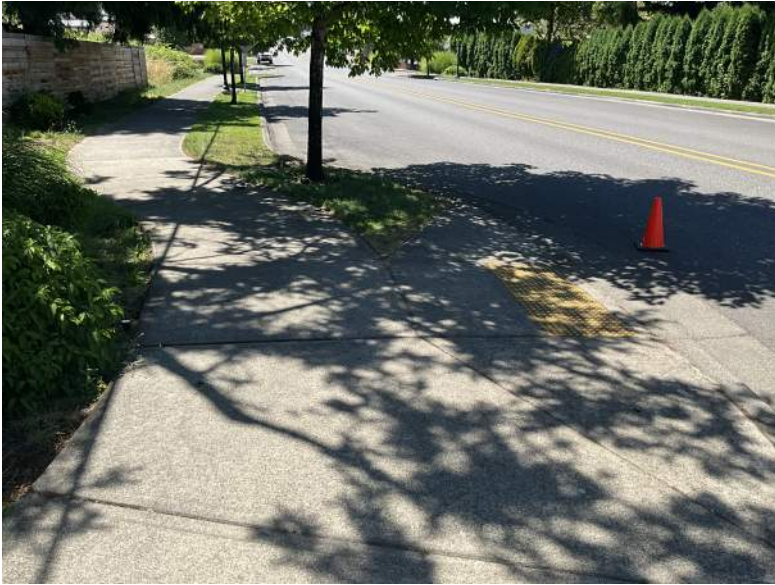
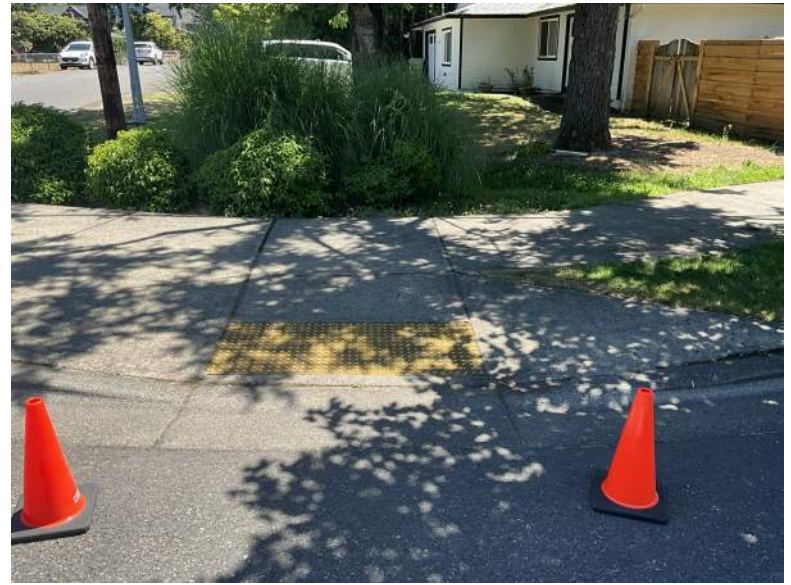
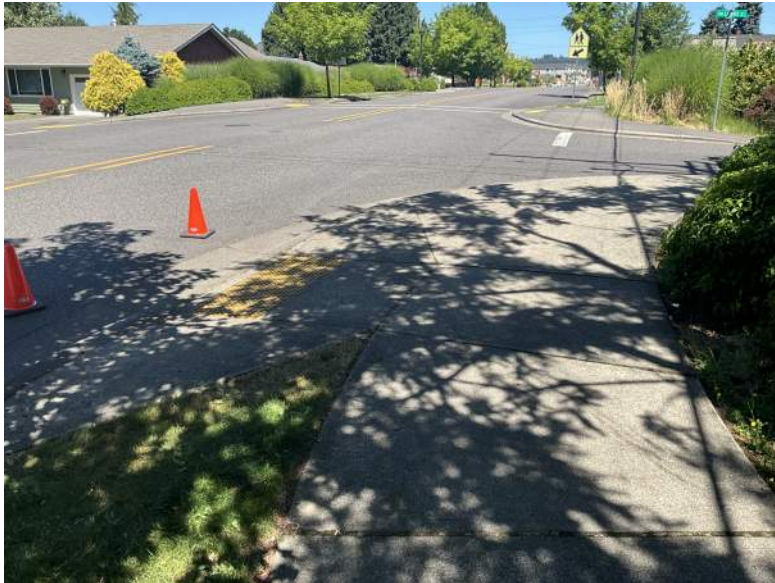
ADA Curb Ramp Images

DWS IITD Fails RR 1
