ADA Curb Ramp New Construction Inspection Form (Blended Transition)

NW. 314TH AVE

24953

NW. COMMERCIAL ST.

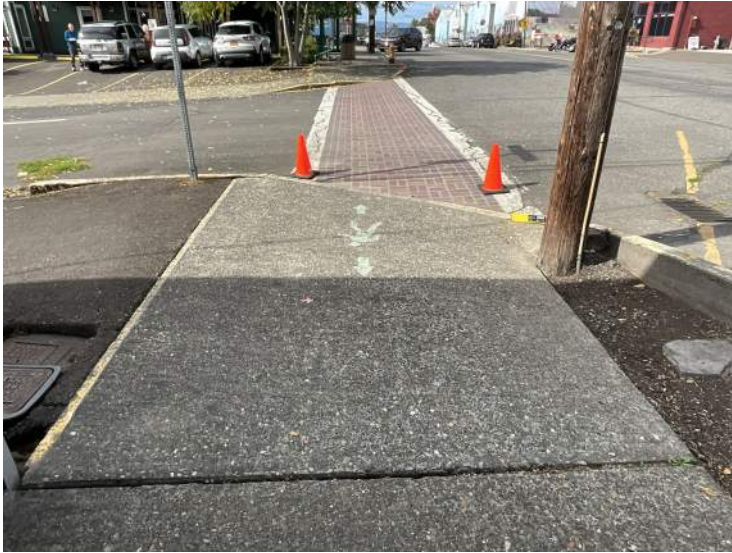
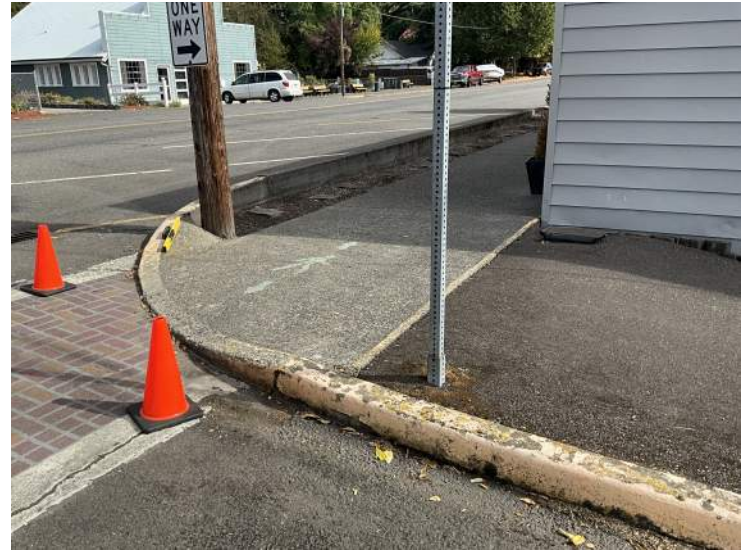
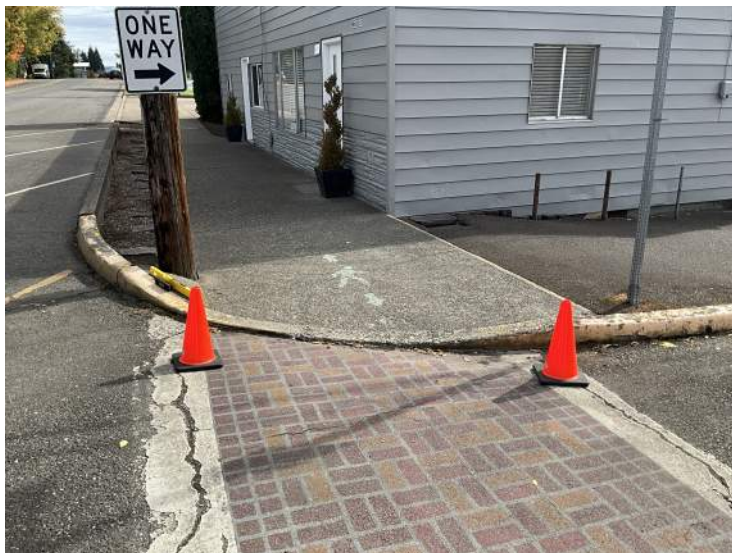
ADA Curb Ramp Images

No dome
