ADA Curb Ramp New Construction Inspection Form (Perpendicular)

Nw 288 ter

Project No.

Nw mays st

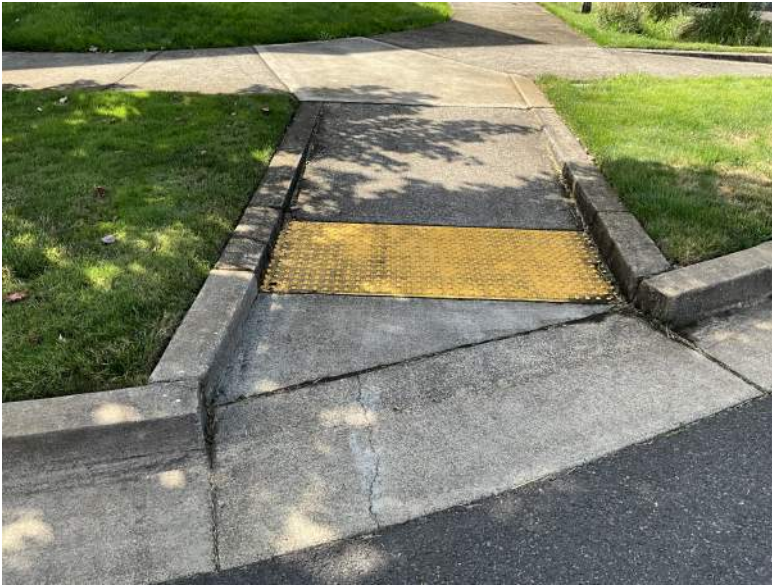
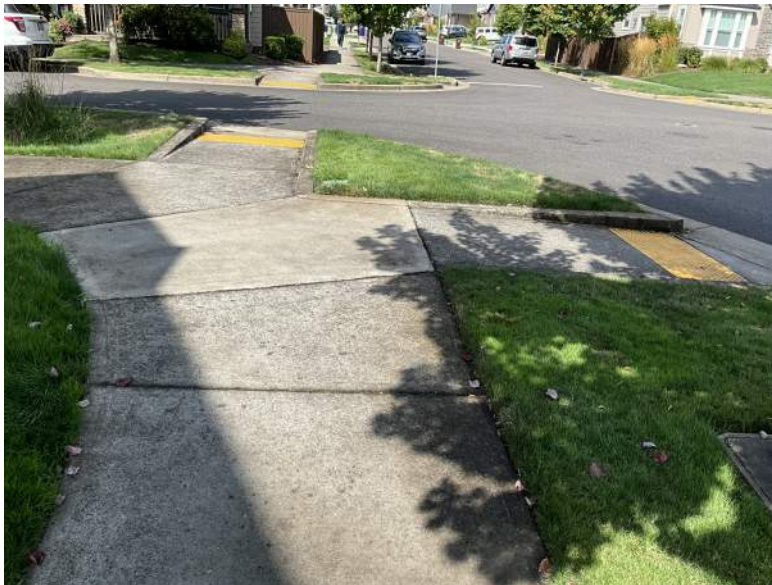
ADA Curb Ramp Images

IITD standing water in gutter
