Task Force SAFE

Inspection-Report_TFSAFE_H4QXY_44444_106_20-12-25_1-2

Base Location	Camp Arifjan (Kuwait)	Date:	2025-12-20
Base Code	H4QXY	Team #:	106
Building #	44444	System Voltage	120/208V
Building Type	Barracks	Inspection Phase	Initial Inspection
Previous Report #:	N/A	Work Order:	TFS-F797V-2025-00001

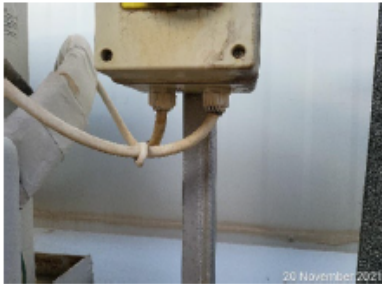
Deficiency #1**RAC 1****Occurrences: 1****Description:** Unlisted equipment

Location:	Main entrance panel
Category:	Unlisted Equipment
Equipment:	CDP
Imminent:	Yes
Action:	Tagged out
Code:	NEC 110: General Rules
Status:	Open

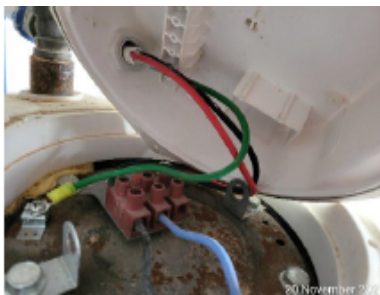
Deficiency #2**RAC 1****Occurrences: 1****Description:** Junction box lids missing

Location:	Hallway junction box
Category:	Poor Workmanship
Equipment:	
Imminent:	Yes
Action:	Reported
Code:	NEC 300: General Requirements for Wiring Methods and Materials
Status:	Open
