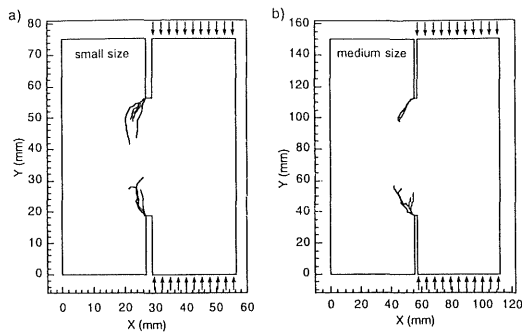
Figure 2. Experimental crack trajectories of double-edge notched specimens of concrete, before the compression failure of the loaded part of specimen. (a) $2h = 75$ mm. (b) $2h = 150$ mm.

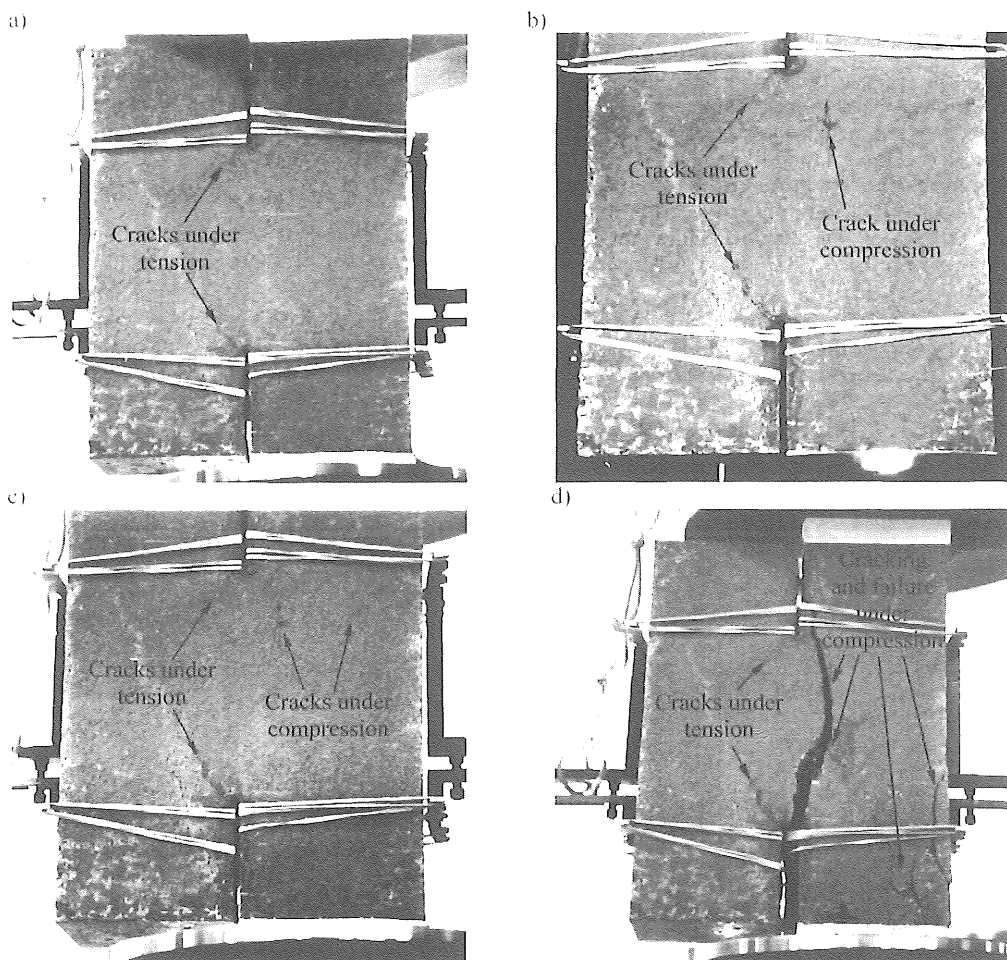
Figure 3. Series of photos showing the sequence of appearance of cracks.
