Overview				Site
Inspect N	34778	Page:	1/1	<b>ROTHERHAM DO/OFF</b>  MAIN STREET  ROTHERHAM  S60 1AA
Job No	12332			
Customer	AECOM			
Contact		Date	26/01/2024	
Tel

ISI Equipment No	Make / Model	Serial No	Client ID
RM090124388	Barrier Traffic		0000056634

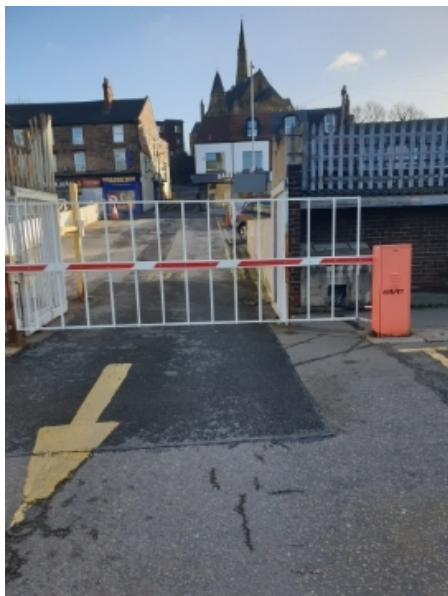
Capture photograph of Asset, including asset number	See Photo 1
---	-------------

Intolerable - Defects requiring immediate action	None
Substantial - Defects requiring attention within a time period	None
Moderate - Other defects requiring attention	Multiple barrier fixings missing or insecure to be rectified.
Tolerable - Observations	None

We advise the equipment be maintained and lubricated in accordance with manufacturers recommendations and a maintenance log maintained for high risk equipment in accordance with Provision and Use of Work Equipment Regulations 1998 ( PUWER ) Regulation 5.
