**JSR Construction Job No.27363: 2 Rapare Street, Rolleston.**

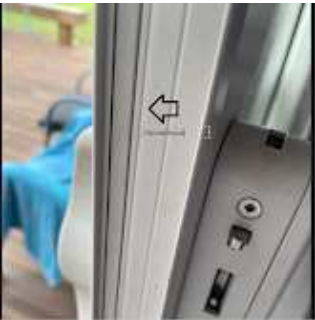
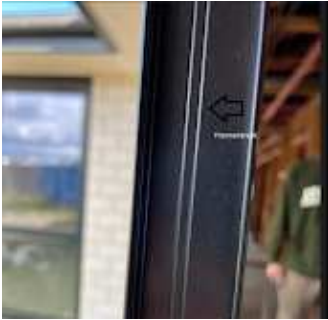
On the photos of the black aluminium frames, the layer marked thermal broken is a strip of aluminium but not the thermal broken layer.

I can see the thermal break in both those photos so no need to go to site.

Hi Tom go see why some doors are not thermal broken

A decision was made by APL to supply non-Thermally Broken Sliding Door Stiles for this reason where a dark colour has been requested. APL have carried out some rigorous testing in relation to the efficiency of the Door Stiles being non-Thermally Broken and the loss in the Thermal Rating is only one – two percent over the entire Frame. With the Non-Thermally Broken Door Stiles the product still meets the minimum R rating and does not affect the performance of the Door.
